Safety Risks to Emergency Responders from Lithium-Ion Battery Fires in Electric Vehicles

Safety Report

NTSB/SR-20/01
PB2020-101011

NTSB/SR-20/01
PB2020-101011
Notation 59989
Adopted November 13, 2020

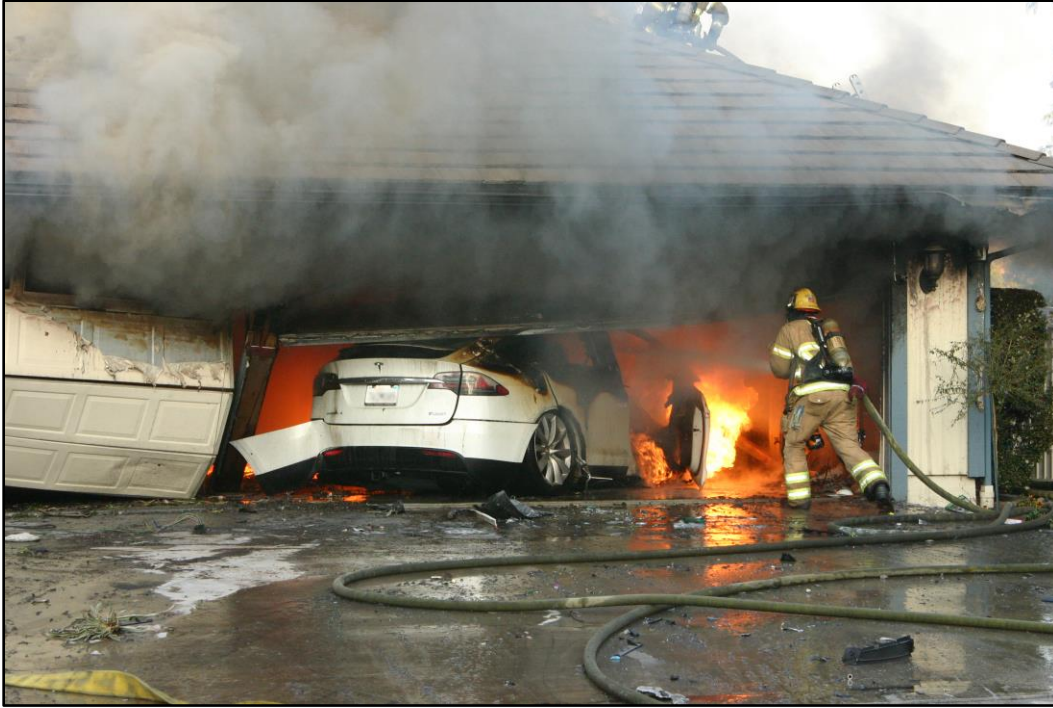
Figure 2. Postcrash view of garage showing firefighter directing water onto burning SUV and smoke coming from garage roof. (Source: Orange County Sheriff's Department)

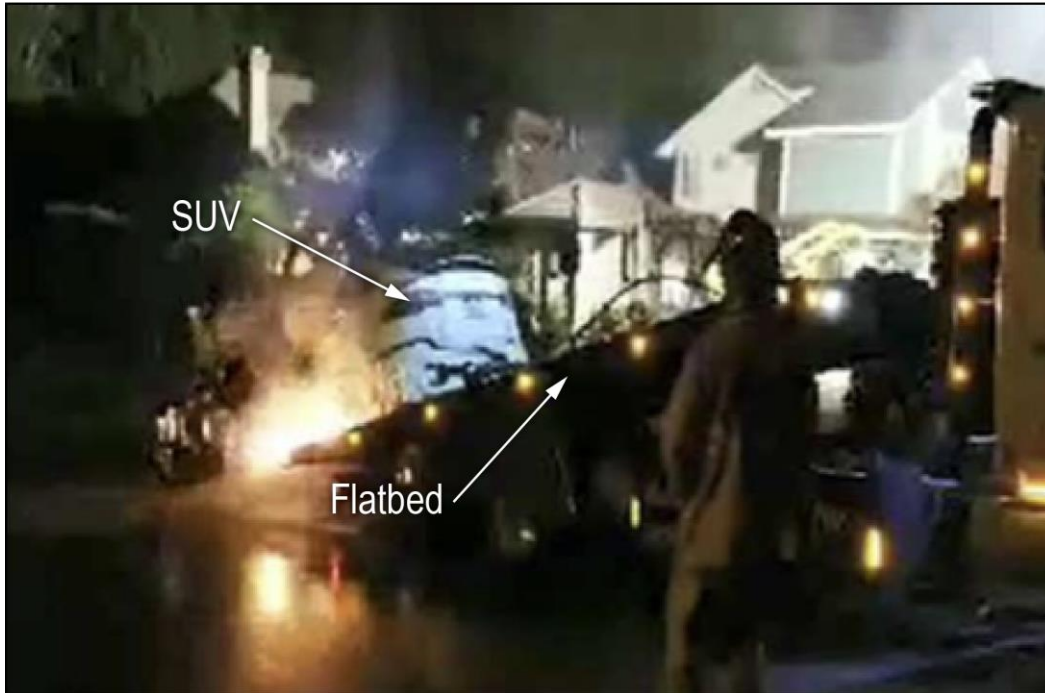
Figure 3. Still image from video taken by sheriff's department officer showing SUV reloaded on flatbed of tow truck. (Source: Orange County Sheriff's Department)

The battery reignited for a few seconds while the SUV was being unloaded at the tow yard. Although the vehicle emitted smoke, it did not catch fire, and the tow driver did not call for an emergency response.³⁴ The SUV was positioned at the tow yard as far from other vehicles or buildings as possible—about 40 feet from other vehicles on two sides, about 20 feet from other vehicles on the third side, and about 10 feet from a concrete wall on the fourth side. According to the towing log, the job was completed at 1:15 a.m.

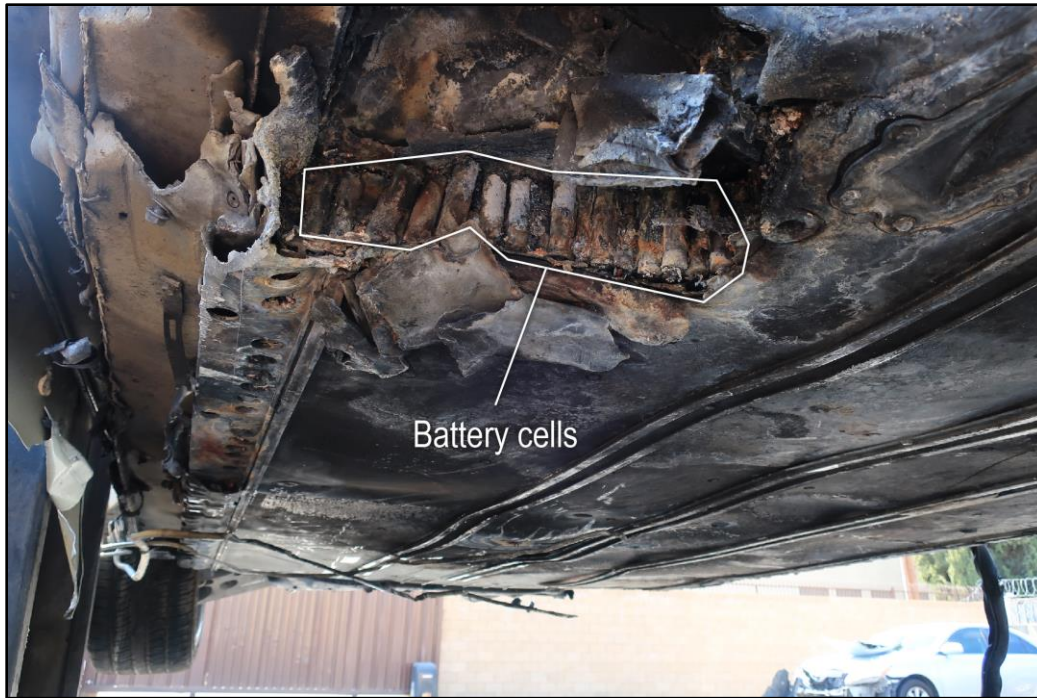
On September 6–7, 2017, NTSB investigators examined the SUV and the battery at the tow yard. They also visited the crash site. The SUV had extensive fire and impact damage. The high-voltage cut loop had been in the area of severe fire and impact damage to the interior, making it impossible to determine whether firefighters had been able to access and cut it. When the vehicle was raised so the underside could be viewed, investigators found that the right front corner of the battery case had ruptured, revealing individual battery cells, as shown in figure 4.

Figure 4. View from below and toward rear of SUV's underside showing ruptured right front corner of battery case and highlighting individual battery cells uncovered by rupture. Right rear wheel is visible in background.

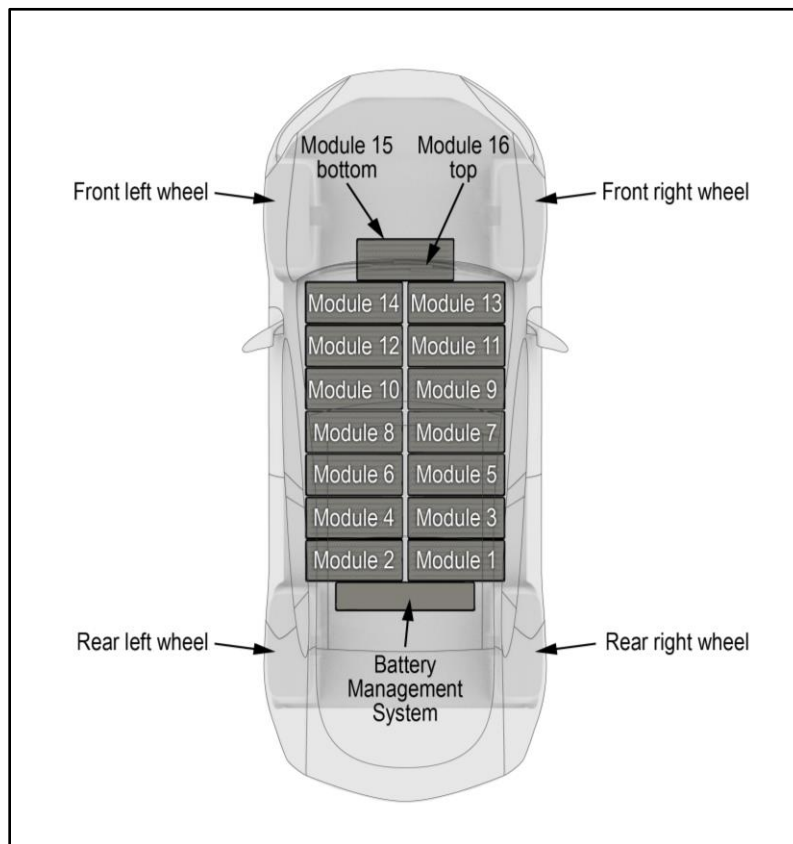
The SUV's lithium-ion battery contained 16 modules (figure 5).³⁵ The rupture exposed parts of modules 13 and 15 at the right front corner, in line with where the right front wheel, brake disk, and other components had been displaced, most likely in the SUV's collision with the drainage culvert. Modules 11 and 9, directly behind module 13, were damaged. Battery cells from modules 13 and 15 had been dislodged or displaced, and individual cells were found on the street, in the driveway, and in the drainage ditch.³⁶

Figure 5. Arrangement of SUV's lithium-ion battery modules.

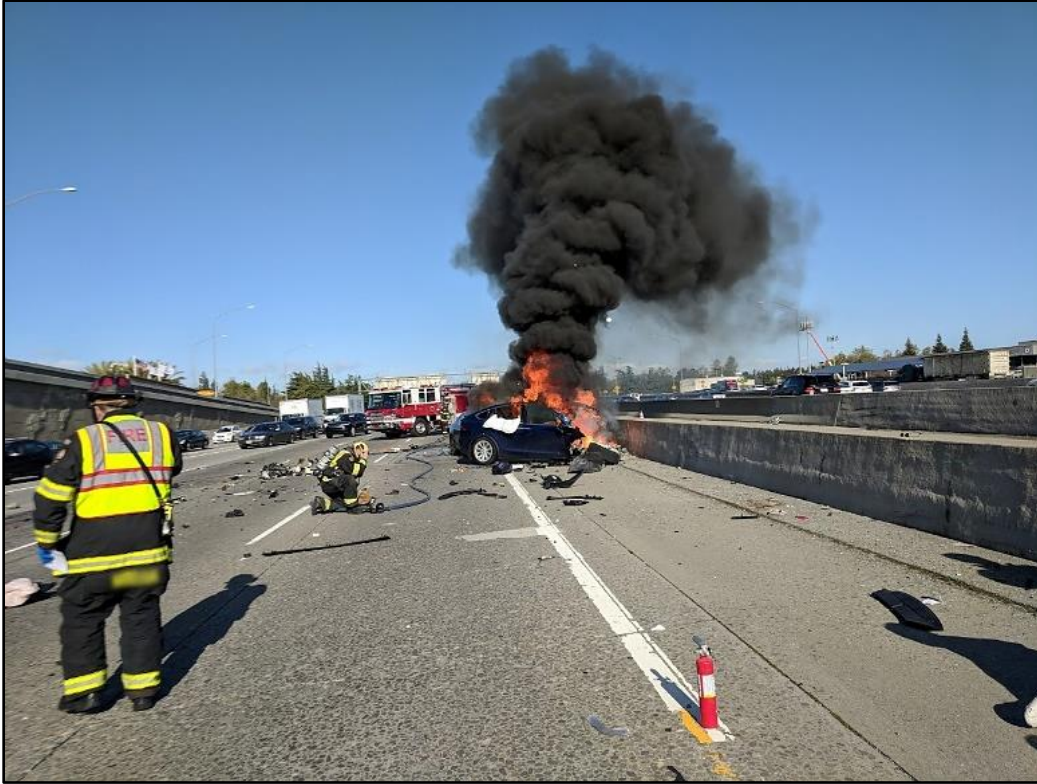
Figure 6. Burning SUV on northbound US-101 postcrash. (Source: witness S. Engleman)

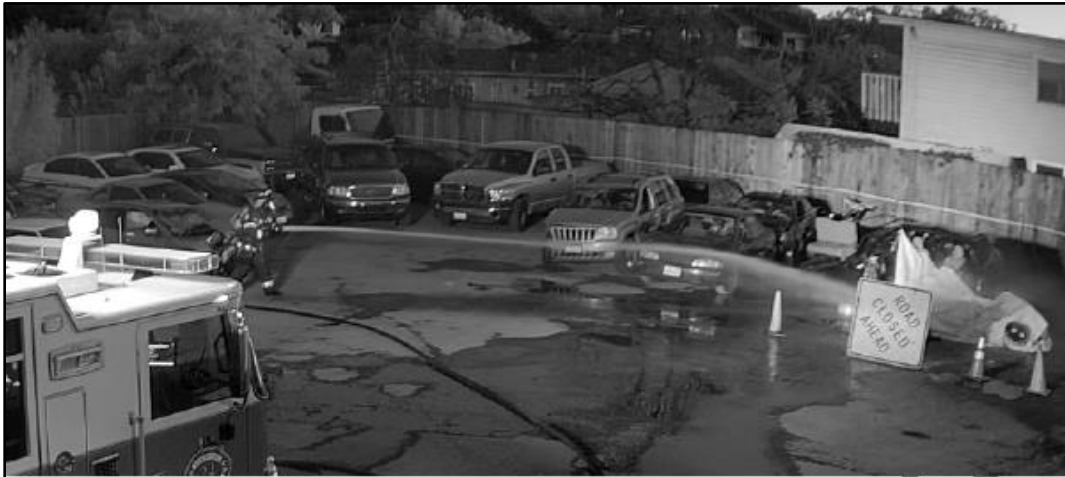
According to the San Mateo Fire Department's dispatch log, firefighters arrived at 7:09 p.m. and reported flames 8 to 12 inches high coming from the right front side of the SUV. Firefighters suppressed the fire using water and foam. A security camera recorded a firefighter applying water and foam onto the SUV, which was still partly covered by the tarp and a road sign that had been used to anchor the tarp (figure 7).

Figure 7. Image from security video at impound yard showing firefighter pouring water onto SUV at right, partly covered by tarp and road sign; fire engine is visible on left. (Source: Atlas Towing)

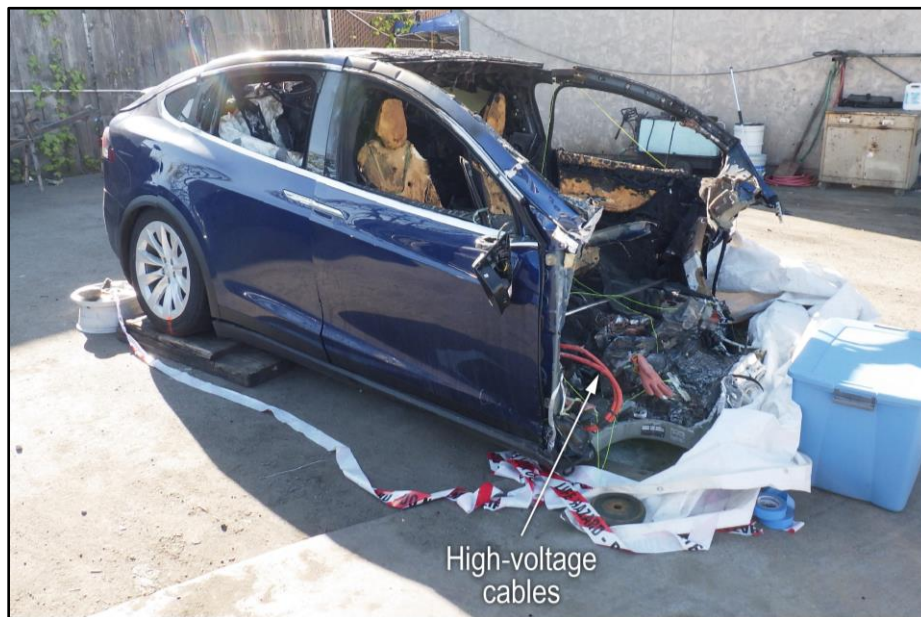
The front of the SUV was extensively damaged. The high-voltage cut loop, normally located at the base of the windshield, was missing, as was the entire front electric motor and other components.⁴⁶ The orange cables that led to the motor and other high-voltage connection points were exposed (figure 8). Attempts to measure the voltage were inconclusive, and any exposed terminals, as well as damaged battery components, were assumed to pose a high-voltage risk.

Figure 8. Damaged SUV with exposed orange high-voltage cables forward of front seat.

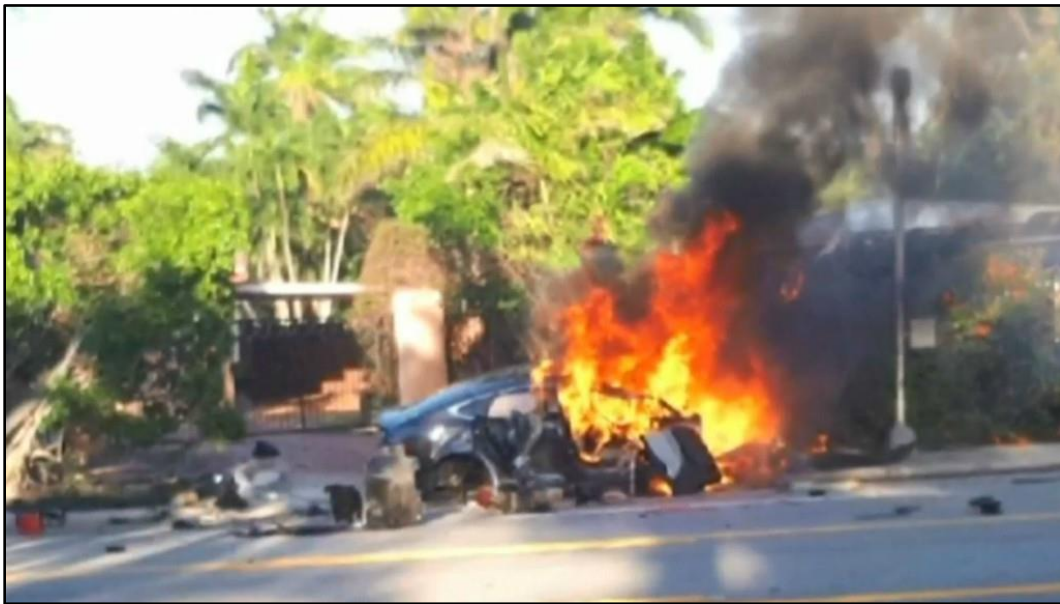
Figure 9. Car burning next to residential driveway postcrash. (Source: CBS4 Miami)

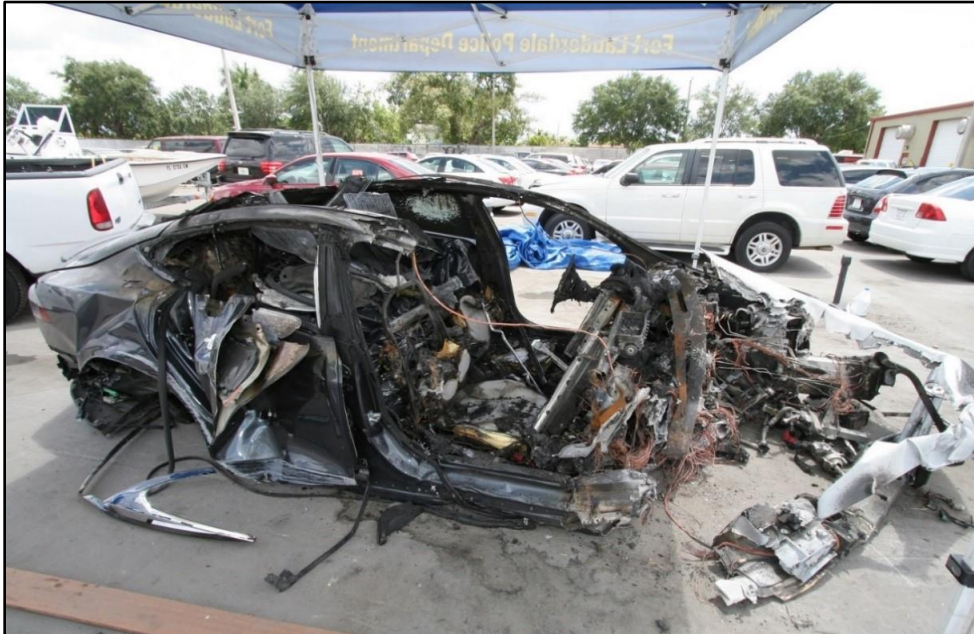
On June 7, 2018, the NTSB met at the tow yard with representatives of the Fort Lauderdale Police Department and Florida Highway Patrol to inspect the vehicle (figure 10) and the debris piles. The items wrapped in the tarp were removed and placed near the vehicle. Individual loose battery cells were found in the tarp, as well as the right front tire and small debris. Large items, including the left front door, front electric motor, right front wheel assembly, and damaged battery modules that had separated from the vehicle (determined to be modules 15 and 16), were found on top of the battery case in the second debris pile (figure 11).

Figure 10. Car parked at tow yard showing severe crash and fire damage.

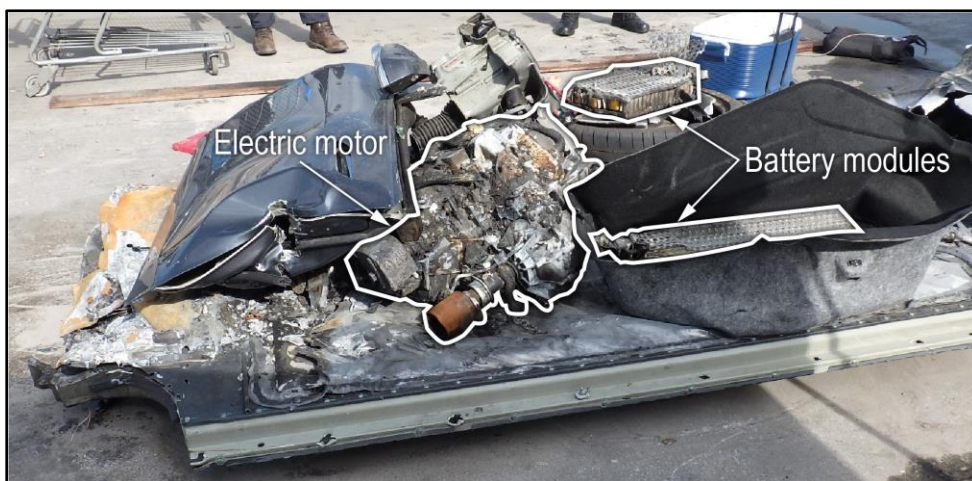
Figure 11. Debris pile on pallet with remains of electric motor and battery modules highlighted.

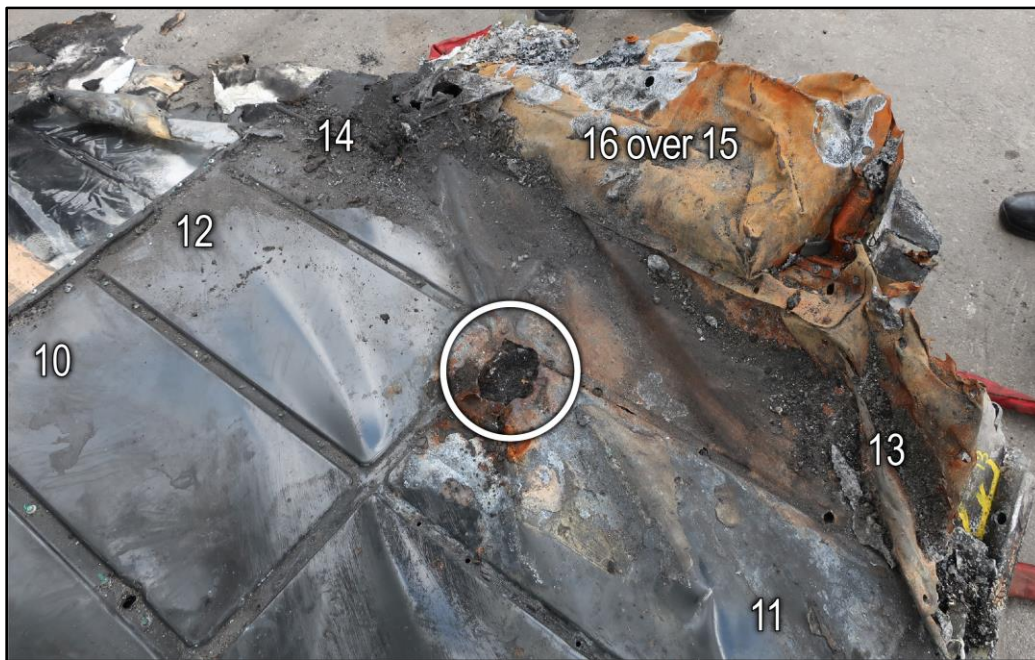
The battery case was severely damaged and ruptured along the entire length of the front surface and extending into the area of modules 13 and 14, which were mounted just behind modules 15 and 16 (figure 12).⁵² Two irregular holes had melted through the battery case, ranging from 3 to 5 inches in diameter. One was on the top of the battery case and would have been between the front seats in the intact vehicle. The other was on the bottom of the case and corresponded to a hole through the floor of the vehicle in roughly the same location. The photograph in figure 12 shows the steel cover on the top of the battery case. The location corresponds to the intersection of four battery modules (Nos. 11, 12, 13, and 14) and is the location of high-voltage connection points. The battery case was significantly warped and deformed in this area.

Figure 12. Top surface of forward part of battery case showing damage to front and hole melted through steel cover (circled), with modules numbered.

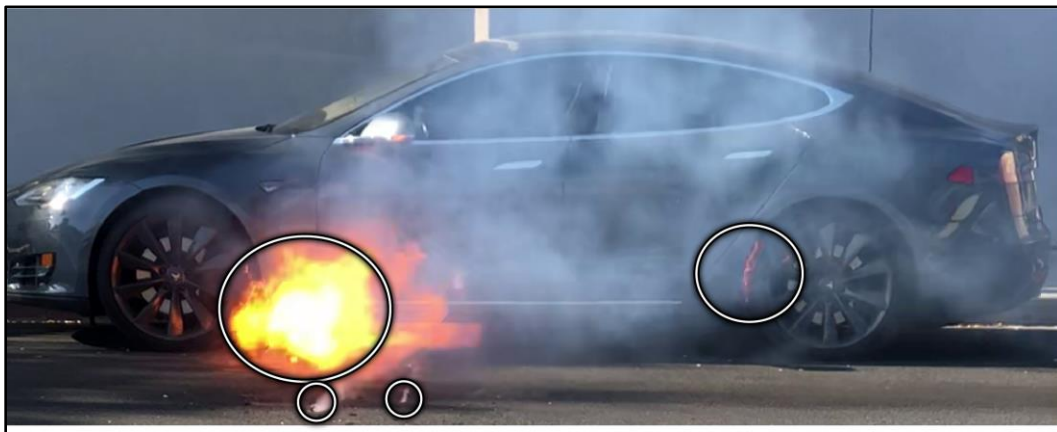
Two people captured videos of the event—a bystander and the driver. Video taken by the bystander captured the left side of the car. Figure 13 is a still image taken from the bystander's video showing fires behind the left front wheel and in the left rear wheel well (large circles), as well as pieces of material ejected from the vehicle (small circles). The image was taken 26 seconds from the start of the bystander's recording and occurred within 2 minutes of the start of the incident.

Figure 13. Image from bystander's video with fire visible behind left front wheel and in left rear wheel well. (Source: Los Angeles County Sheriff's Department)

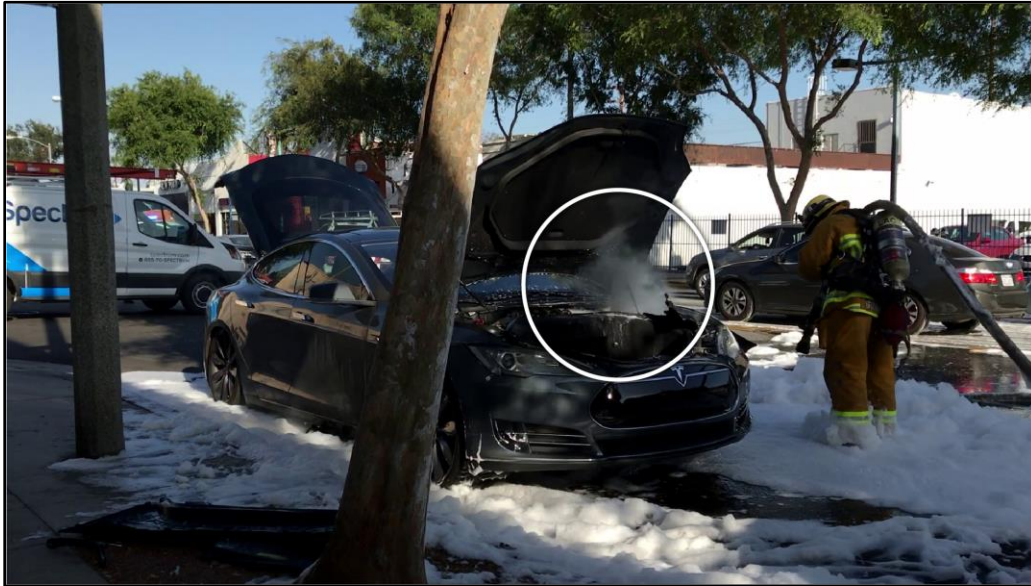
Figure 14. Image from driver's video showing car after flames were extinguished but with smoke still rising (circled). (Source: car's driver)

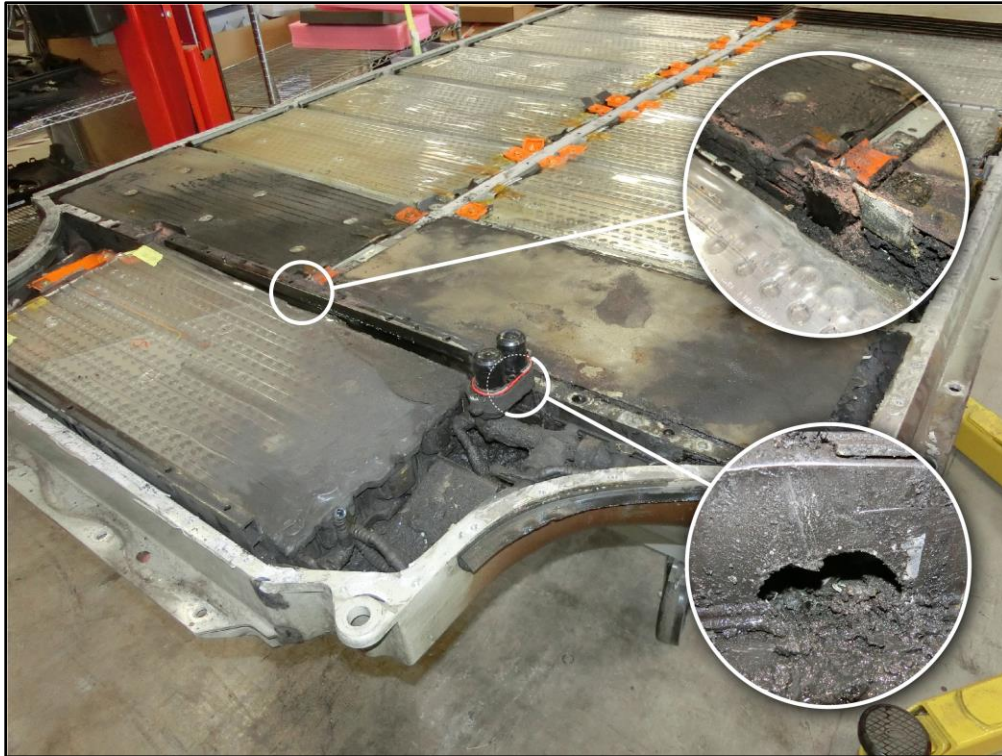
NTSB investigators attended a second inspection in Sunnyvale to view the damage to the vehicle, the battery, and the battery case and to observe the effects of thermal runaway. The vehicle inspection was followed by a teardown of the battery pack. The battery case exhibited holes at the left and mid-front that appeared to be caused by venting gas. Figure 15 shows the whole pack, with damaged areas circled and insets highlighting details of the damage. The damage created paths for vented gas and flames to reach both the left- and right-side overpressure vents of the battery pack. The damaged areas were photographed after debris and parts of the battery pack were removed.

Figure 15. Battery pack with top cover removed to show location of holes in battery case and insets showing closeups of damaged areas.

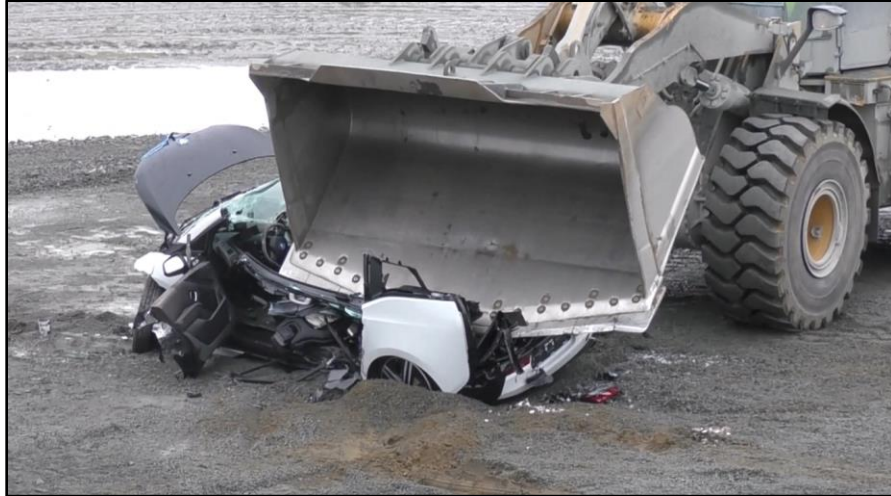
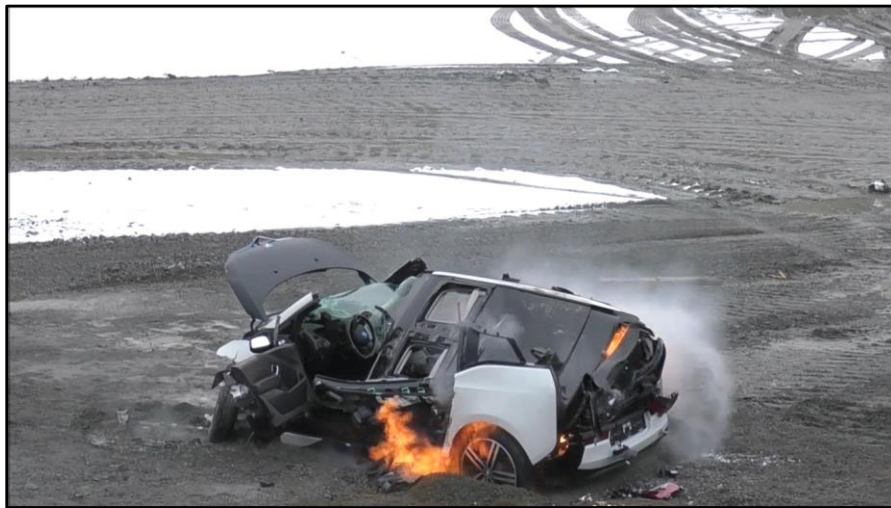
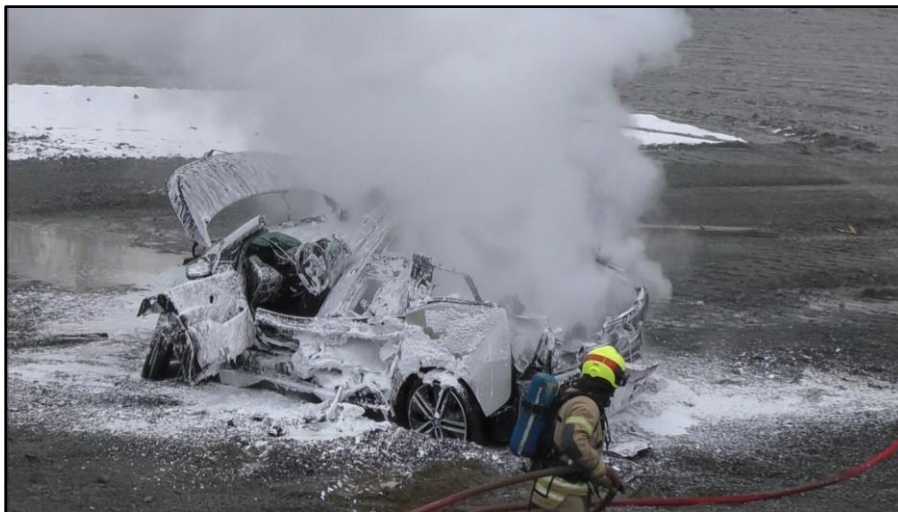
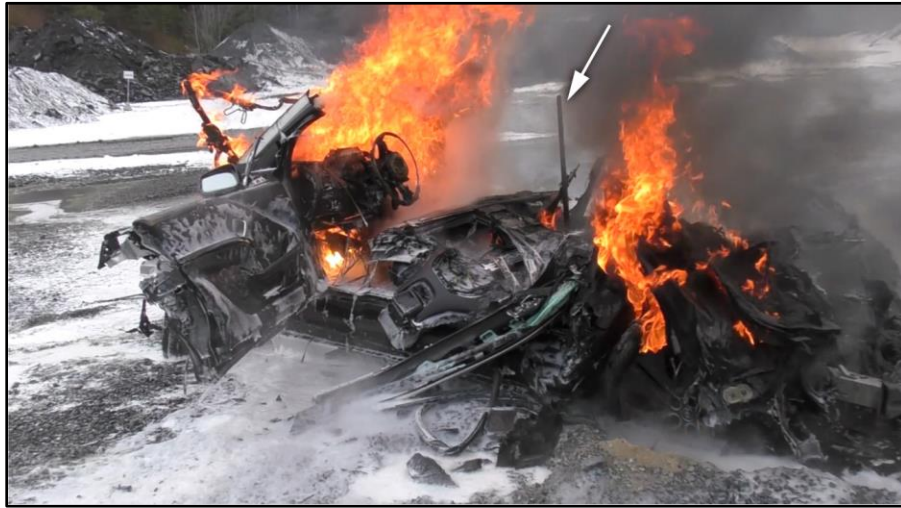
Figure 16. Series of images showing (a) attempt to trigger short circuit by crushing car with bulldozer; (b) flames erupting 8 minutes after piercing car with metal rod; (c) flames no longer visible, but battery continuing in thermal runaway; and (d) fire burning itself out, with arrow pointing to metal rod. (Source: NFRD video)

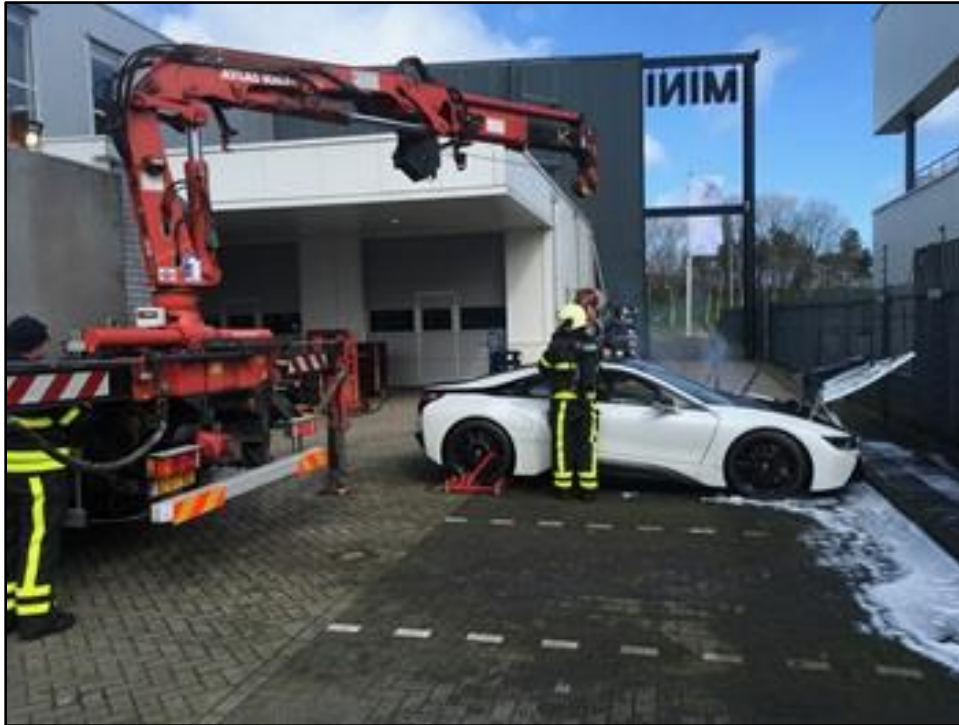
Figure 17. BMW after firefighters attempted to extinguish fire, with crane positioned above and faint plume of smoke visible above car’s windshield. (Source: Central and West Brabant Fire Brigade)

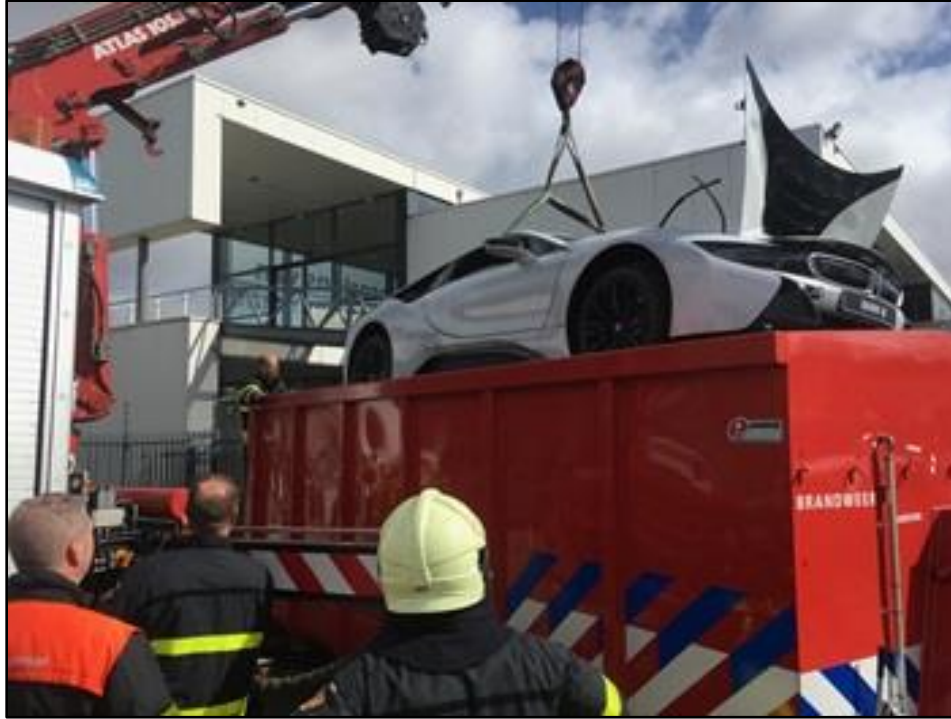
Figure 18. BMW being loaded into tank filled with water. (Source: Central and West Brabant Fire Brigade)
