# Best Practices for Emergency Response to Incidents Involving Electric Vehicles Battery Hazards: A Report on Full-Scale Testing Results

*Final Report*

Exponent, Inc.  
17000 Science Drive, Suite 200  
Bowie, MD 20715

© June 2013 Fire Protection Research Foundation

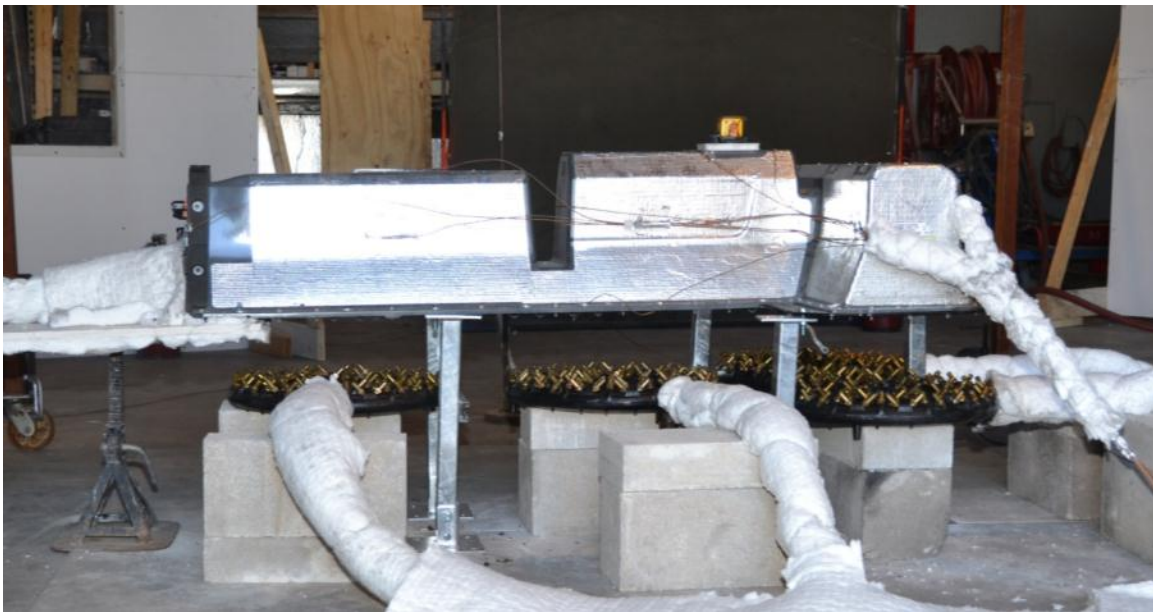
Figure 11 Battery B configuration and burner locations for HRR testing

Battery B was centered under a 20 foot by 20 foot hood supported by five stainless steel legs, as shown in Figure 11 and Figure 12. The leg supports held the battery in place, twenty inches above the ground to provide a viewing angle to the bottom of the battery during testing.

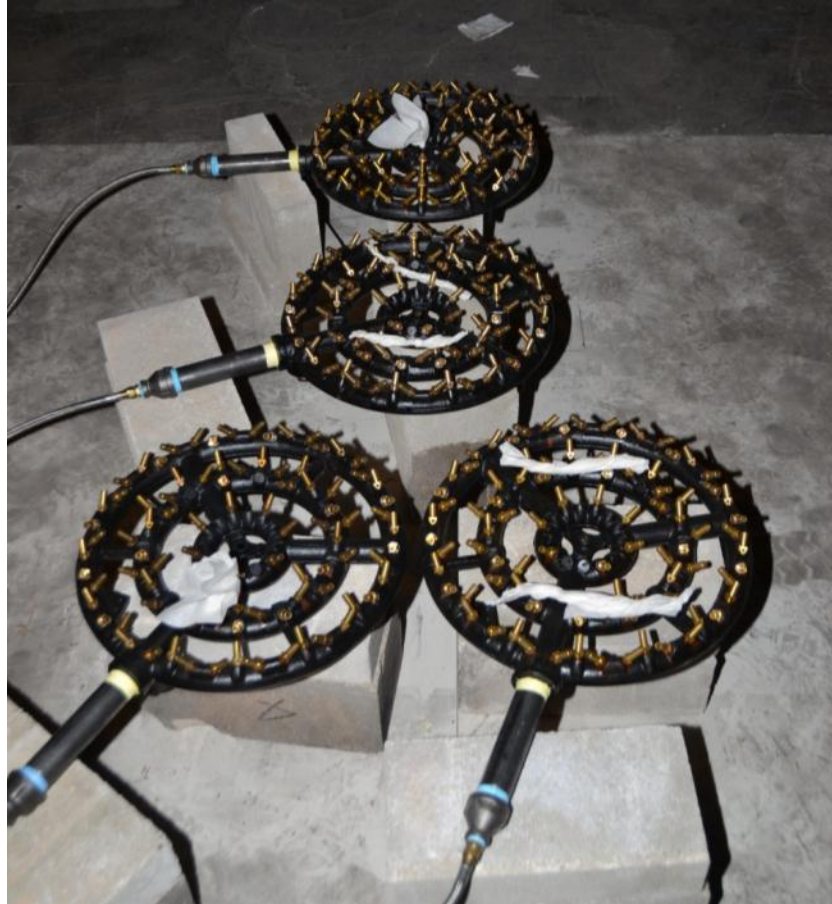
Figure 15 T-shaped burner arrangement comprised of four burners

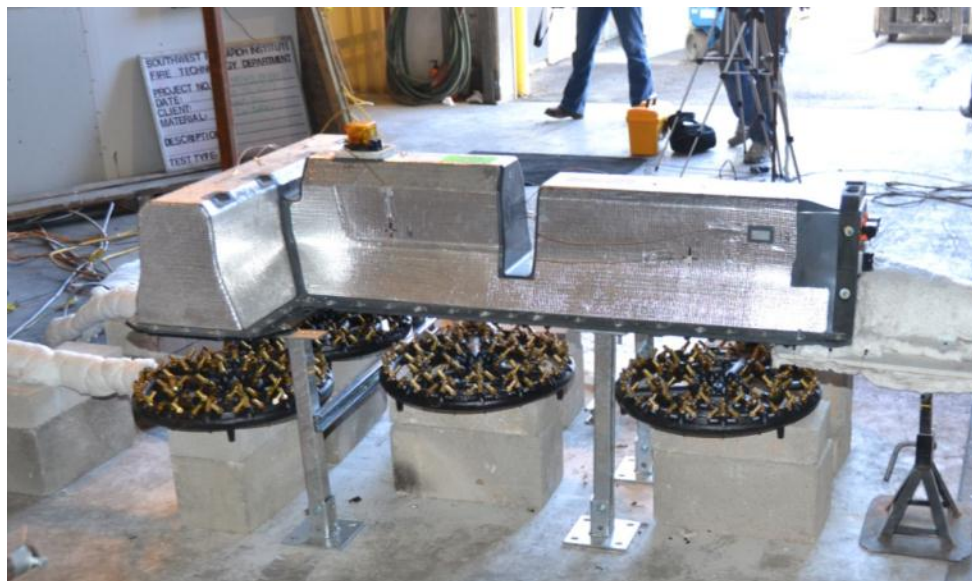
Figure 16 Four burners positioned under Battery B

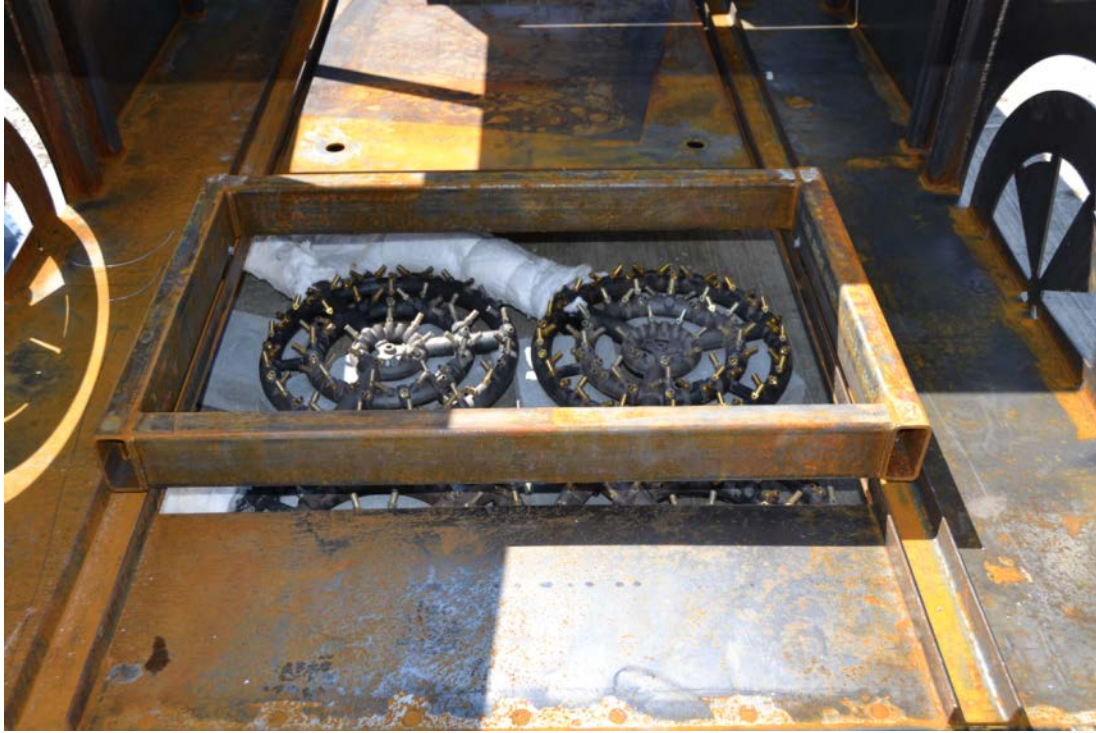
Figure 25 Carriage installed inside the VFT positioned above the four burners located in the rear test position

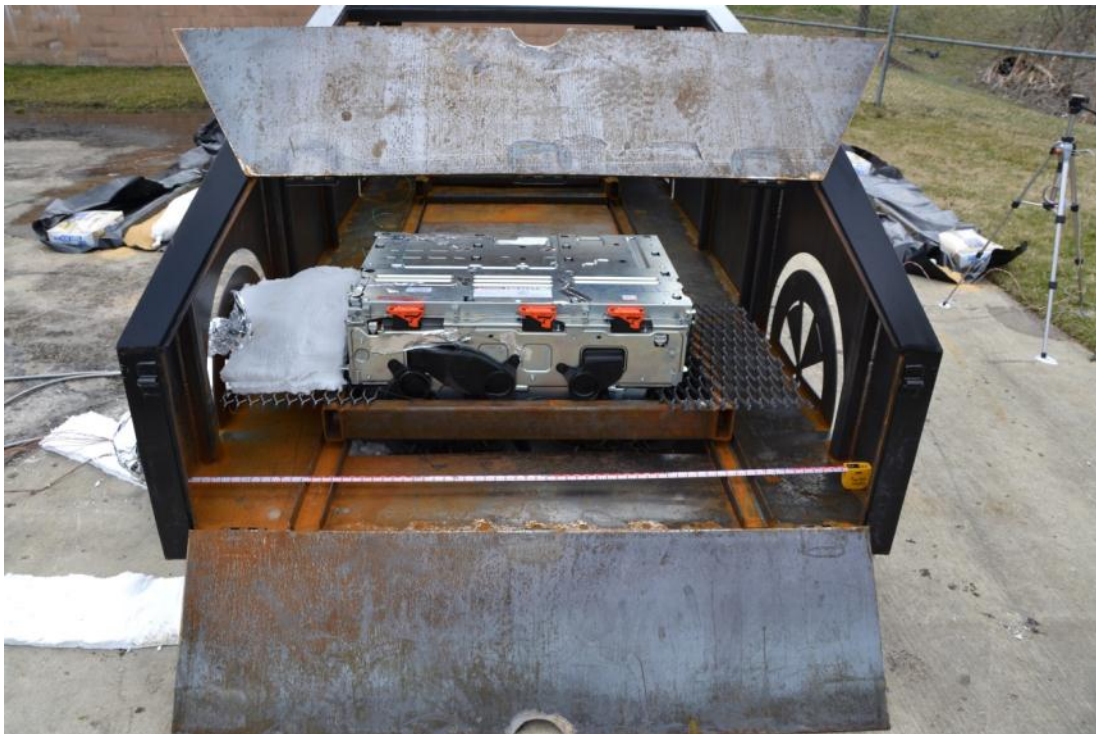
Figure 26 Battery A positioned on the carriage above the burners and inside the VFT

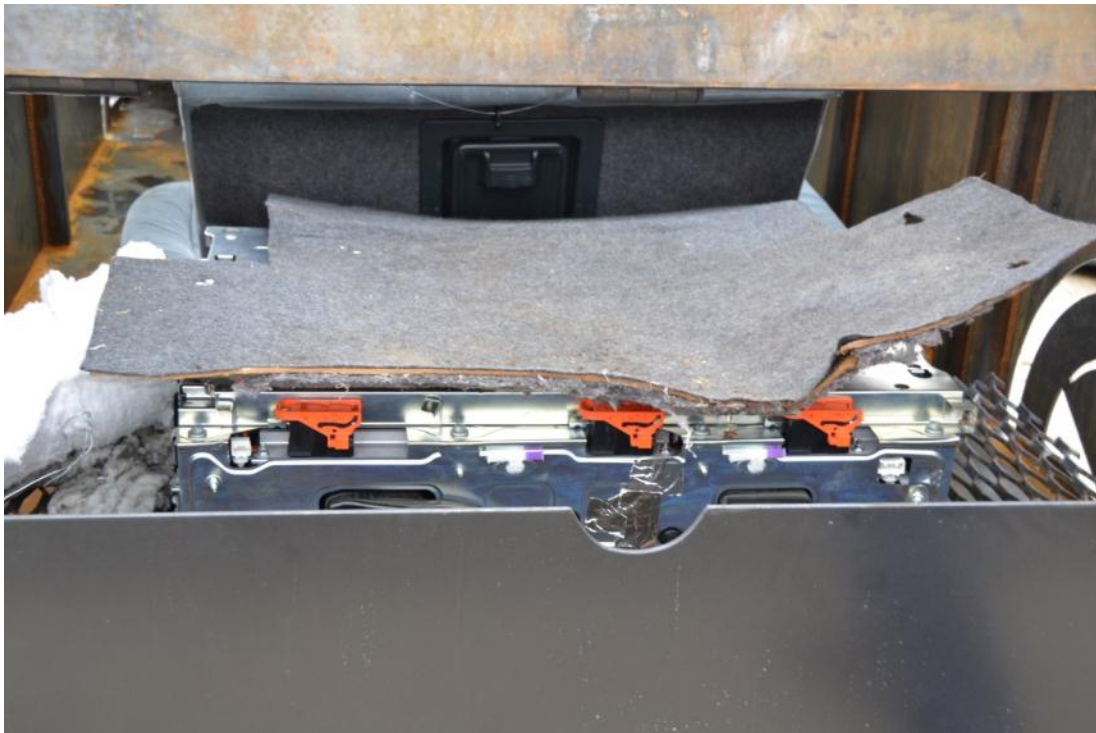
Figure 33 Carpet installed on top of the battery for Test A3

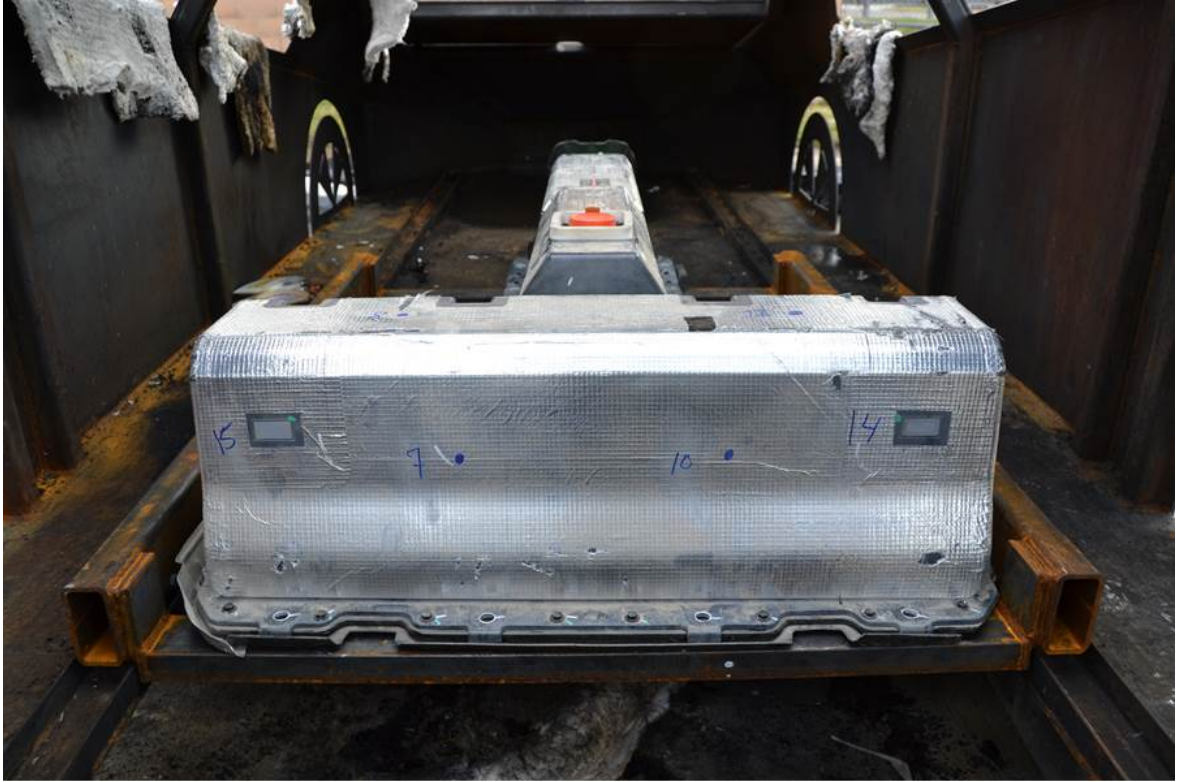
Figure 34 View of Battery B inside the VFT without the floor pan (top) and with the floor pan (bottom); the blue tank at the rear of the battery is the empty gasoline tank for the production vehicle, which blocks direct access to the rear of the battery

For Battery B, the four burners were positioned under the span of the T-shaped battery to provide a uniform heat source to the entire battery pack, as described in Section 5.1.2 for the HRR test. Inside its production vehicle, a steel floor pan is positioned on top of the battery, separating it from the passenger compartment. As such, the vehicle manufacturer that donated Battery B also donated a steel floor pan from an actual vehicle to be placed above the battery during testing. This configuration provided a more realistic vehicle fire scenario, as shown in Figure 34 and Figure 35. For the first two tests, Tests B1 and B2, the battery and the steel floor pan were installed within the VFT. For Test B3, typical interior finishes/upholstery, including car seats, a dashboard, and carpeting were added to the VFT along with the battery and steel floor pan, as shown in Figure 36 through Figure 40. The car interiors were procured from vehicles of a similar size to the VFT. These additional vehicle interior finishes were installed to better simulate the typical fuel load expected in a vehicle fire.

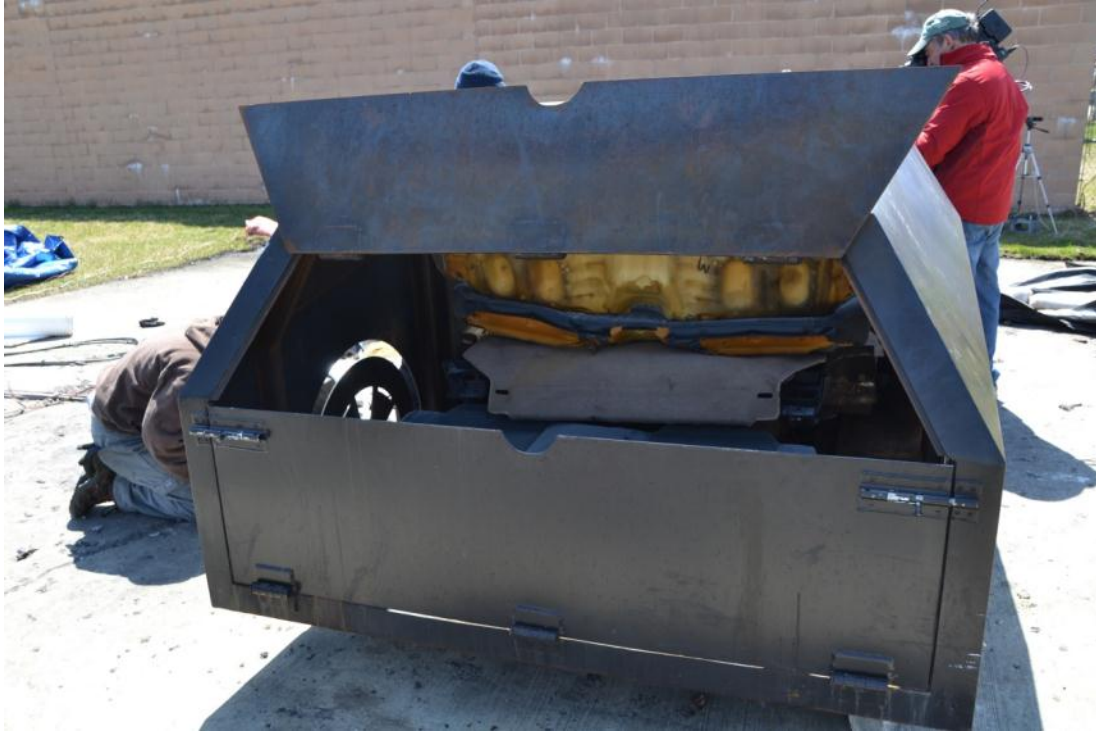
Figure 40 Back seats and carpet installed inside the VFT for Test B3

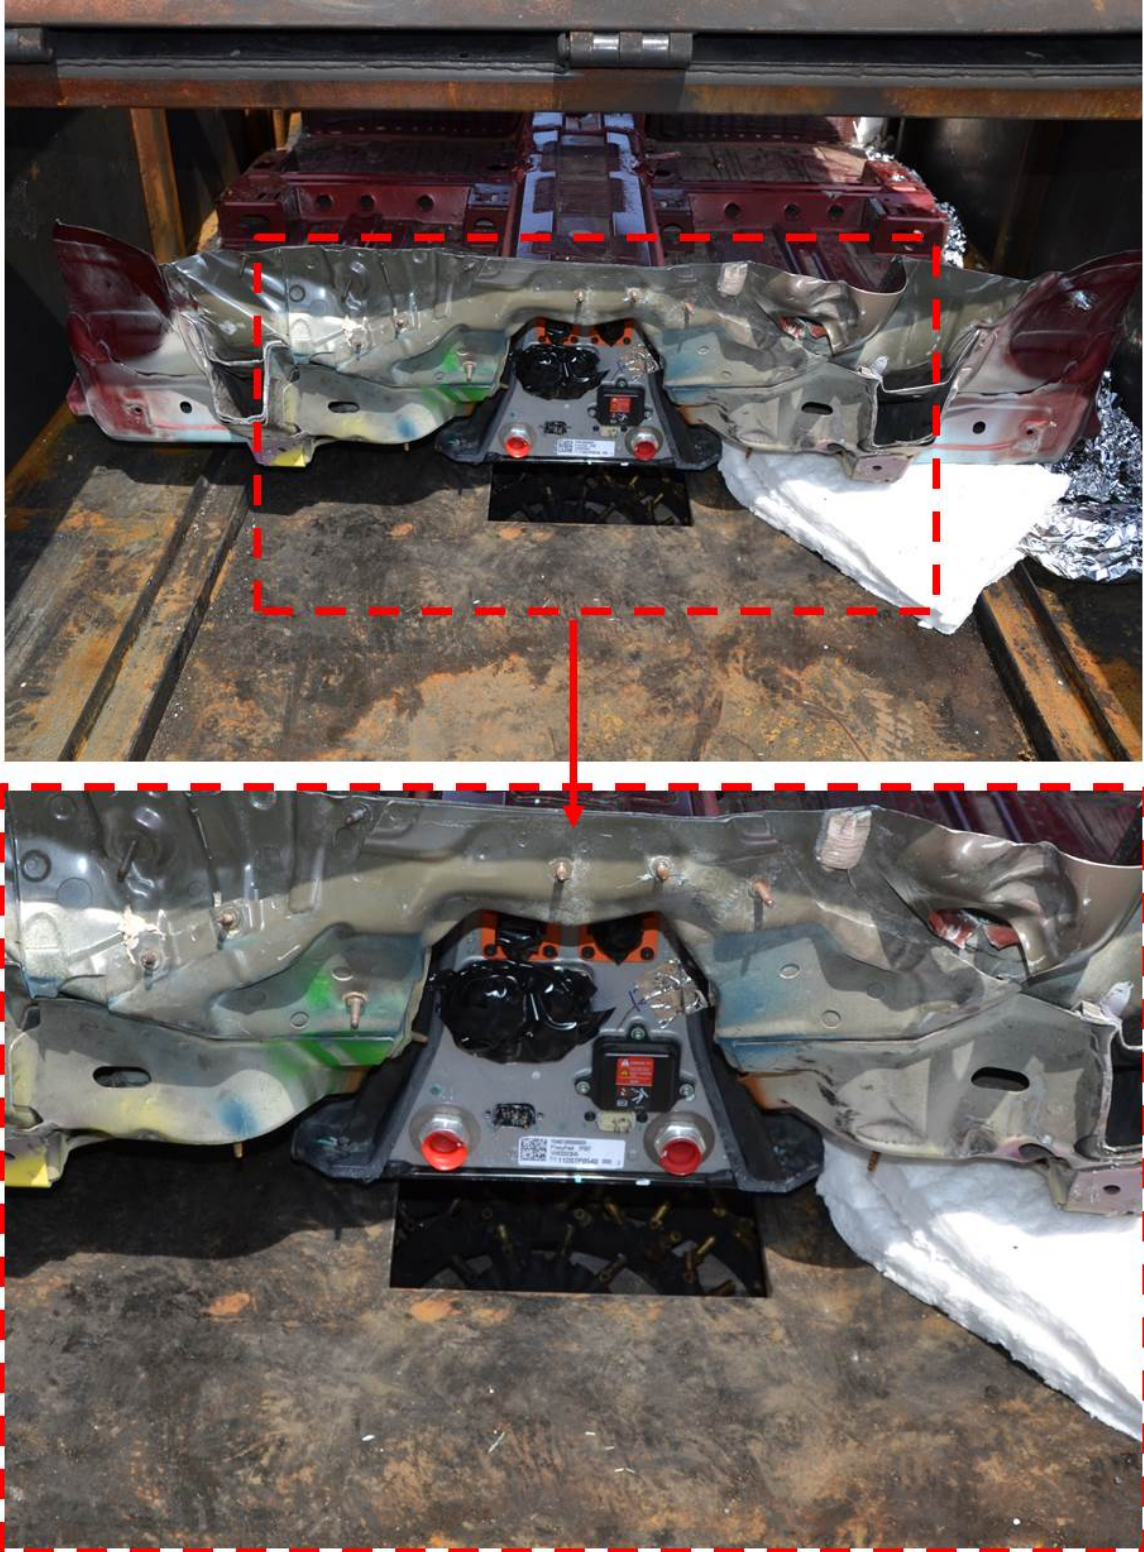
Figure 46 Connection points to Battery B once installed inside the VFT (before protection)

During the Battery B tests, Exponent collected internal battery temperatures and individual cell voltages from the battery's own sensors. Exponent was not provided with the necessary supporting information to communicate with the A series batteries. These measurements were collected for as long as the connection between the battery and the DAQ system would allow (i.e., that is until fire exposure conditions compromised the communication paths). To collect this data, Exponent communicated directly with the battery using the same software programs, cables, equipment, sensors, and connection points to the battery described in Section 5.1.6. Prior to the suppression tests however, the battery was installed within the VFT, which required a slightly modified protection scheme for the battery's connection points. To protect these connection points, a modified calcium silicate board structure was erected around the front end of the battery once it was positioned within the VFT, as shown in Figure 46 and Figure 47. This structure shielded the connection area from direct flame impingement by the burners below, as well as any flames licking around the bottom edge and sides of the battery. In addition, Kaowool was inserted into the structure to insulate the connection points further and wrapped around the cables running to the battery from the DAQ system.

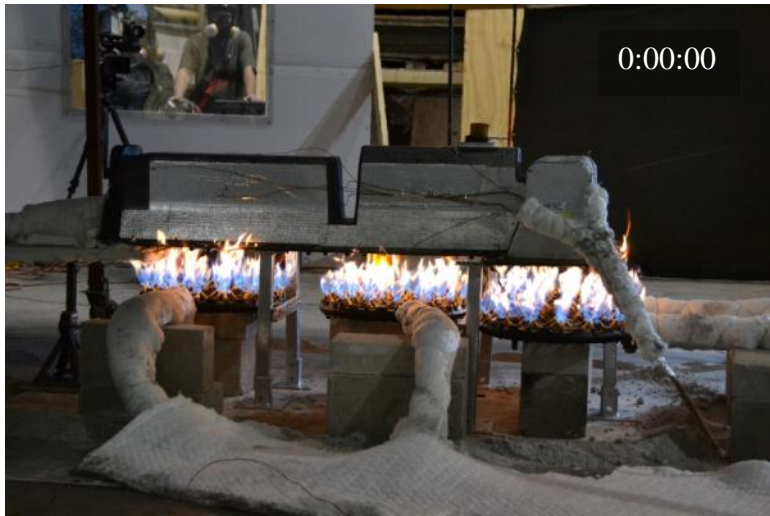
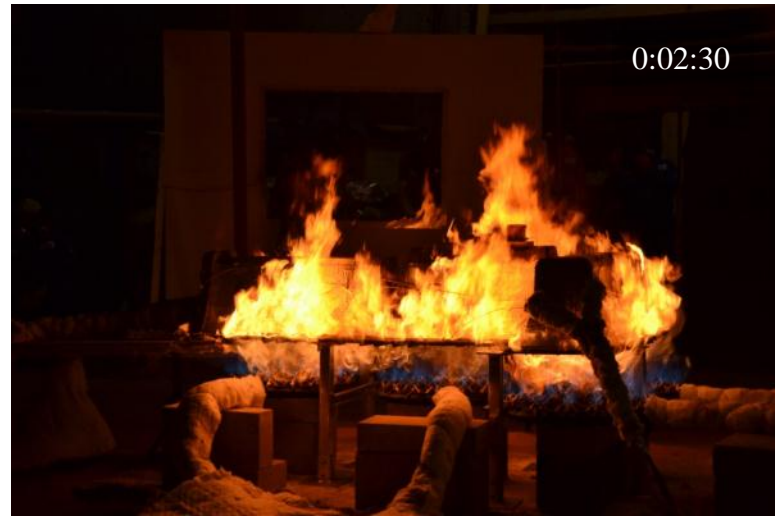
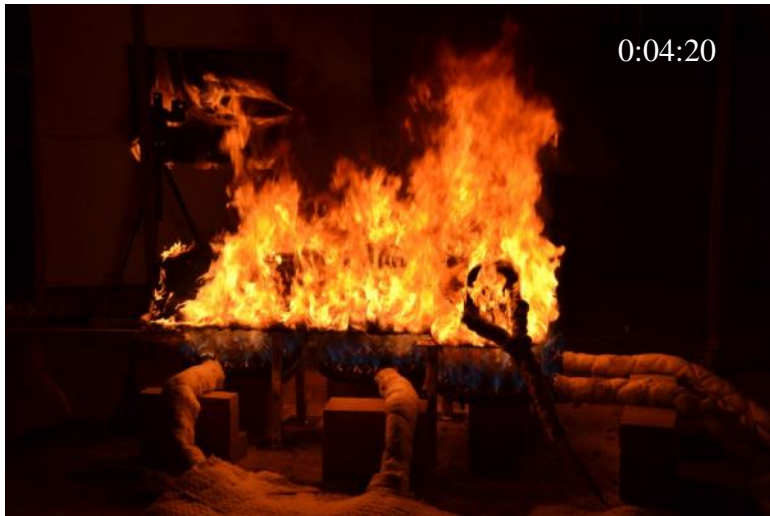
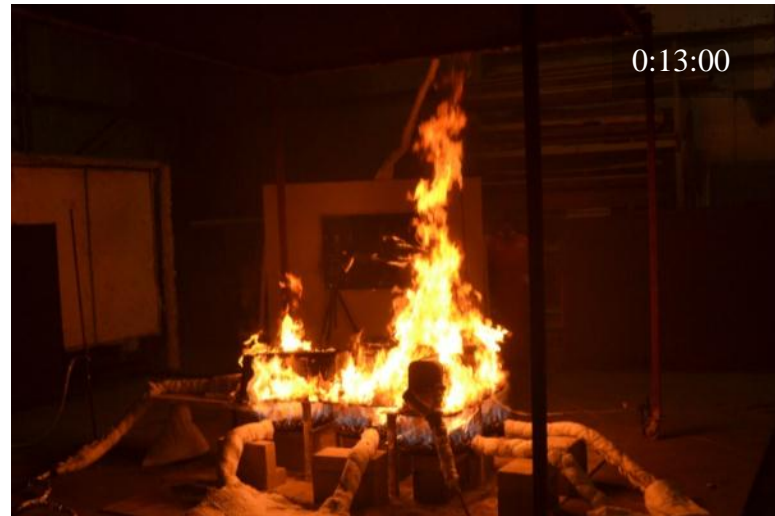
Figure 50 0 minutes (top left), 2:30 minutes (top right), 4:20 minutes (bottom left), 13 minutes (bottom right)

1:03:00	Loud pop heard and the fire at the top fuse goes out
1:20:00	Loud popping heard
1:30:00	Loud popping heard
1:34:00	Last flame goes out, battery continues to smoke

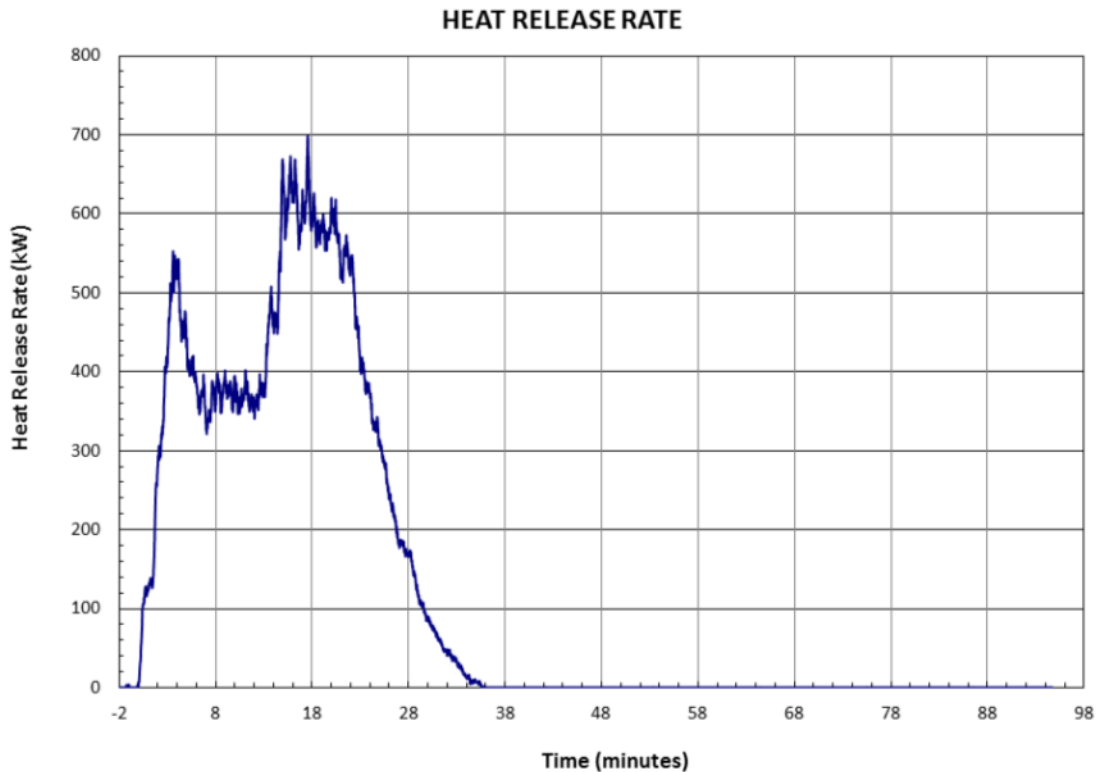
Figure 53 HRR as a function of time

In addition to the maximum HRR reported in Table 7, the average HRR over the entire 90 minute test and the total heat release were calculated to be 128 kW was 720 MJ, respectively.

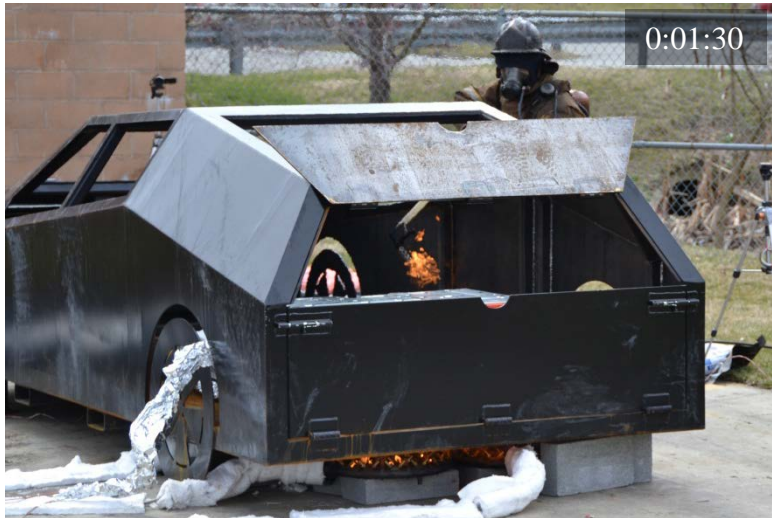
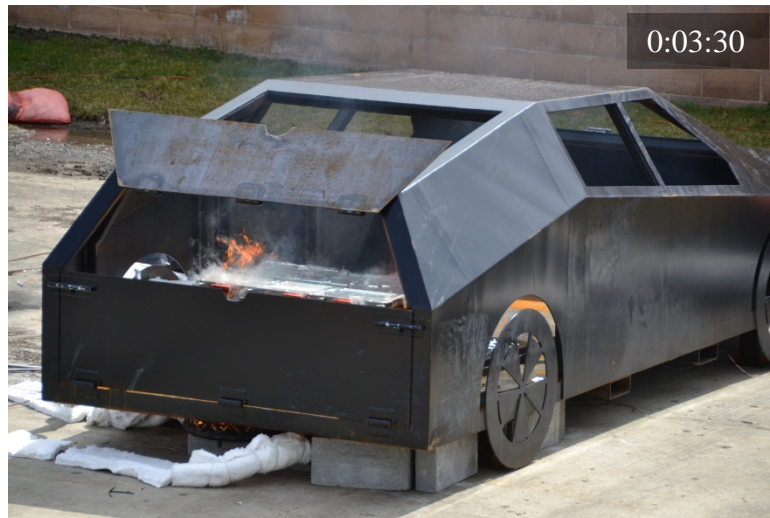
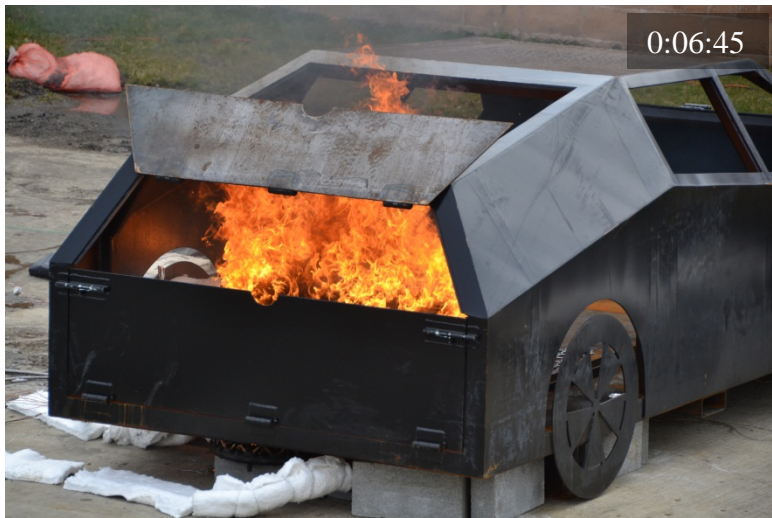
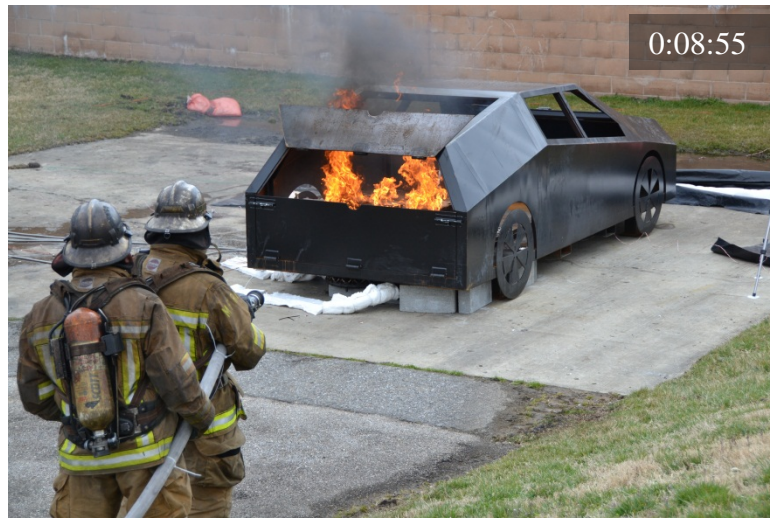
Figure 57 Test A1: ignition (top left); off gassing (top right); fully involved (bottom left); burners off (bottom right)

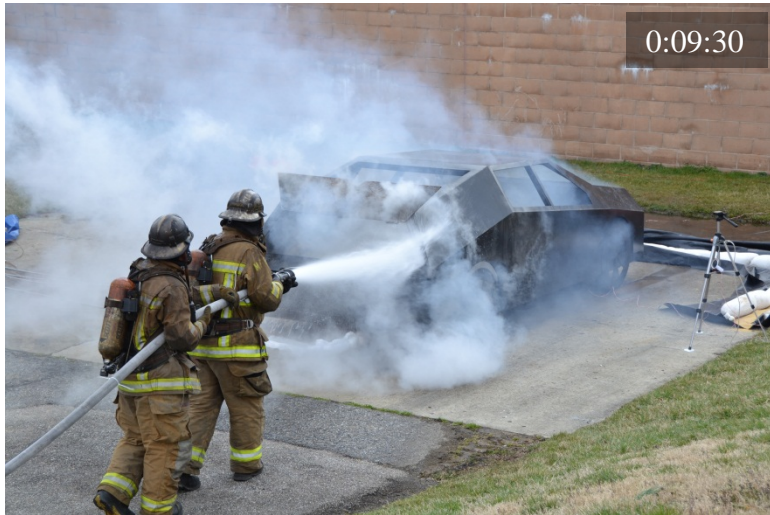
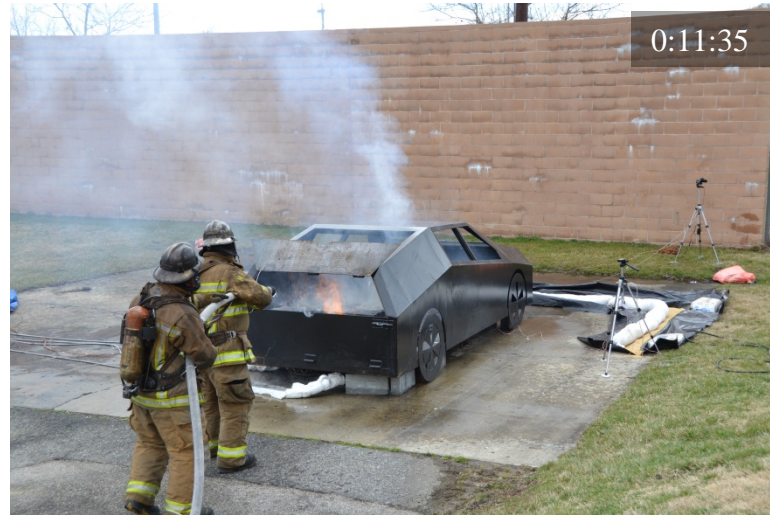
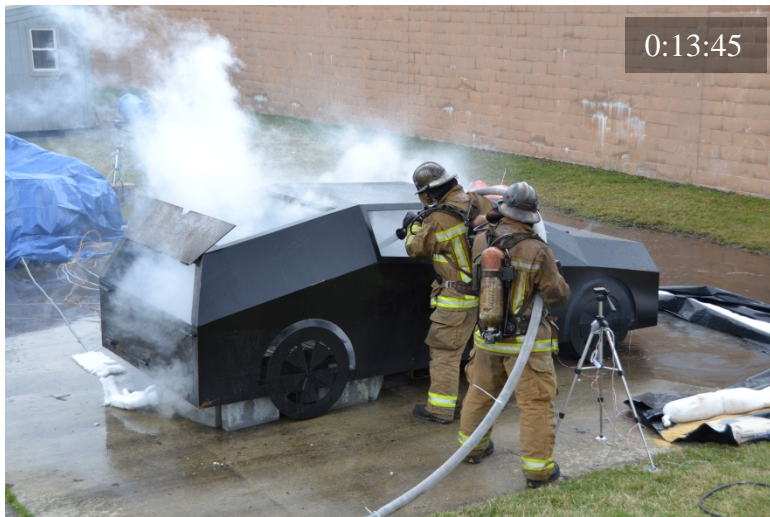
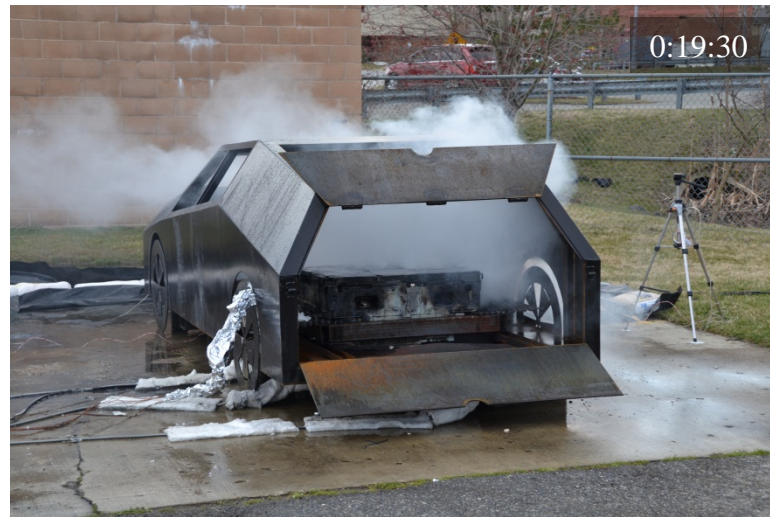
Figure 58 Test A1: Suppression starts (top left); reignition and suppression (top right, bottom left); post suppression (bottom right)

<b>Time</b>	<b>Event</b>
0:11:45	Battery fire reignited and suppressed
0:12:15 – 0:12:23	Electrical sparks observed
0:13:00	Pops
0:14:30	Start water application up into rear ports of battery
0:14:43	Sparks observed
0:18:26 – 0:19:04	Off gassing / white smoke
0:23:18	Pops
0:35:20	Off gassing / white smoke
1:00:00	Data acquisition off

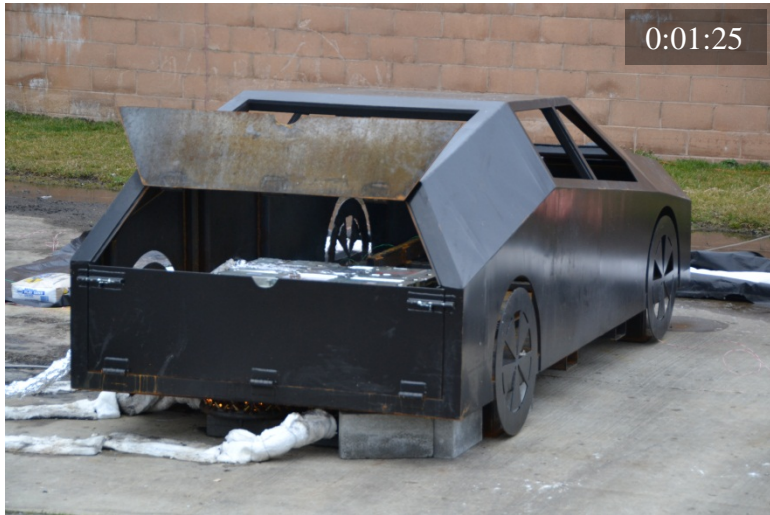
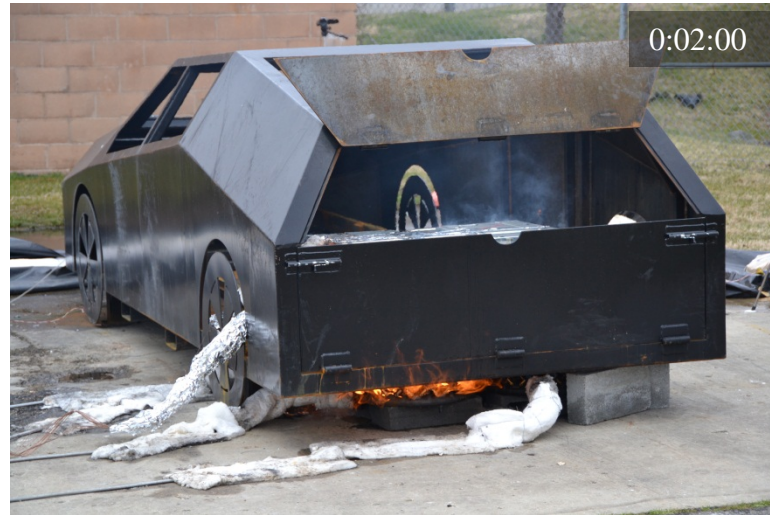
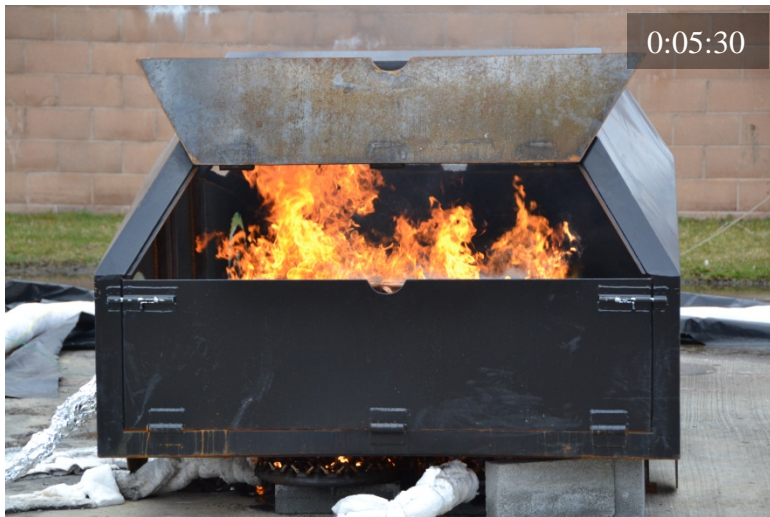
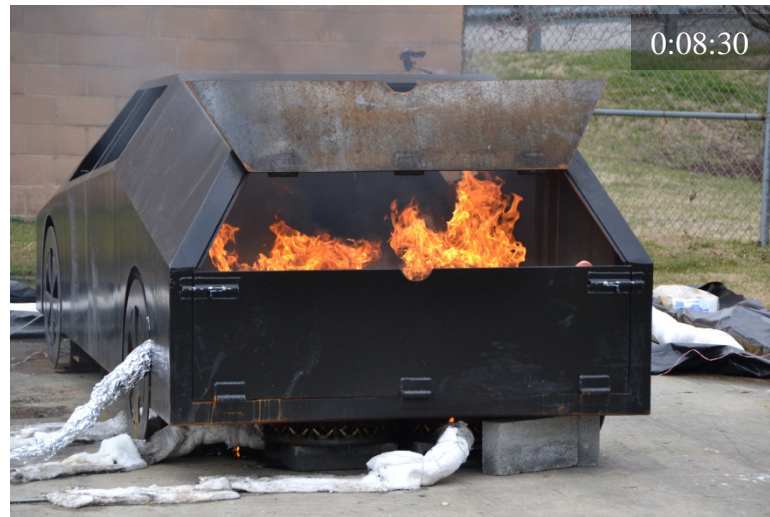
Figure 62 Test A2: ignition (top left); off gassing (top right); fully involved (bottom left); burners off (bottom right)

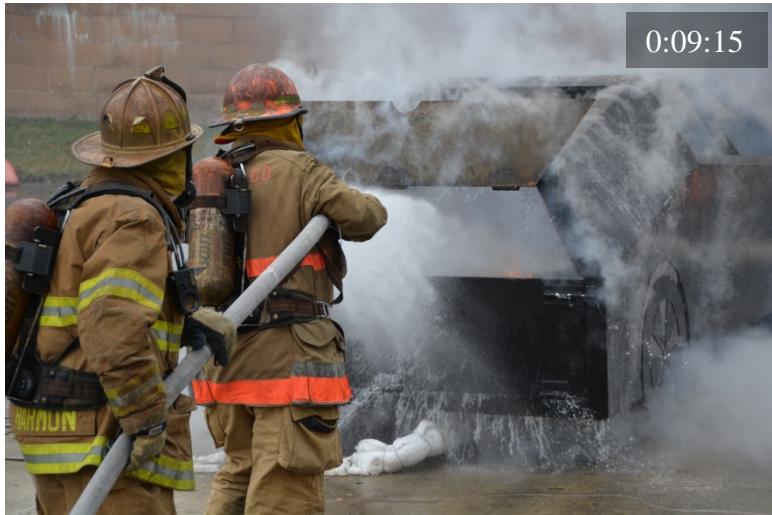
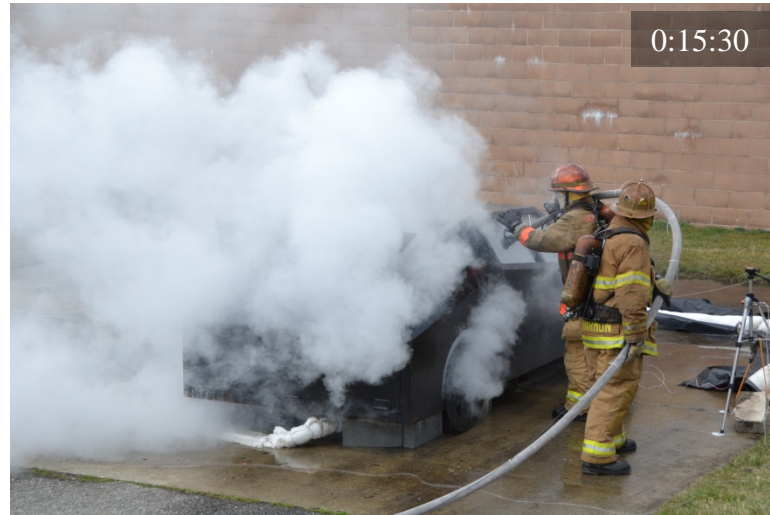
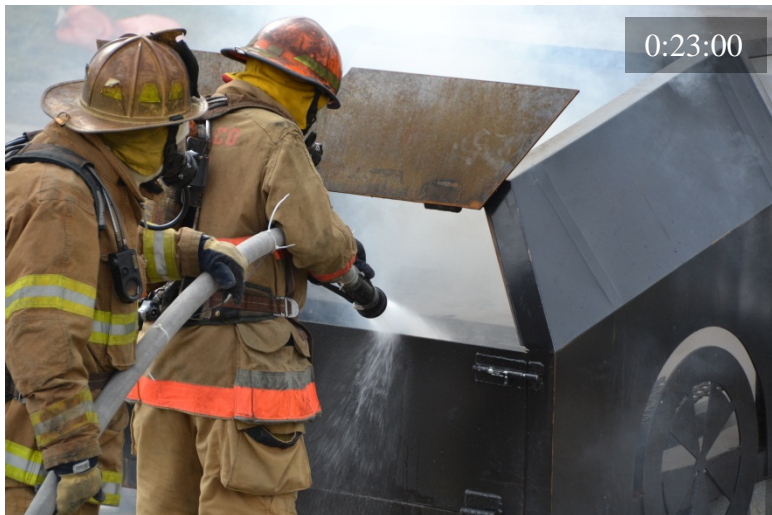
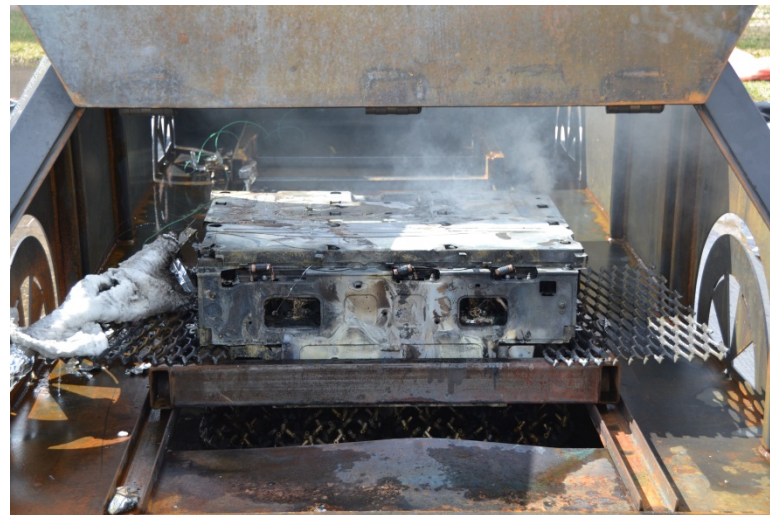
Figure 63 Test A2: suppression starts (top left); reignition and suppression (top right, bottom left); post-suppression (bottom right)

<b>Time</b>	<b>Event</b>
0:08:52	
0:09:11	Suppression starts from rear of the vehicle
0:09:48	Battery fire reignited
0:10:21 – 0:12:57	Sporadic pops with heavy white smoke off gassing
0:13:29 0 0:15:07	Would hear a “whoosh”, then observe arcing and heavy white smoke off gassing
0:15:21	Battery fire reignited
0:15:33	Firefighters attack fire from passenger side window
0:16:02 – 0:21:48	Sporadic pops with heavy white smoke off gassing
0:23:06	Battery fire reignited
0:24:26	Battery fire reignited
0:26:31	Small pop
0:26:48	Firefighters attack fire from rear of vehicle
0:27:36 – 0:37:20	Occasional small pops
0:44:00	Battery fire reignited
0:44:49	Firefighters insert nozzle directly into right vent hole on metal battery case
0:47:55	Pop
1:00:00	DAQ system off

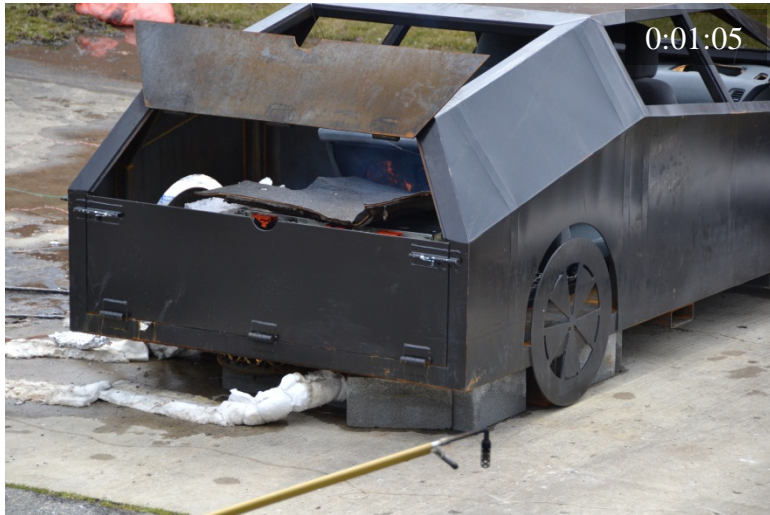
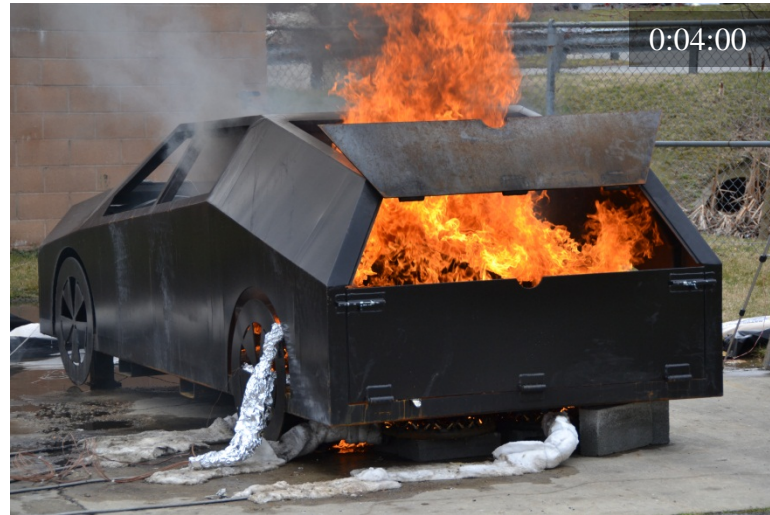
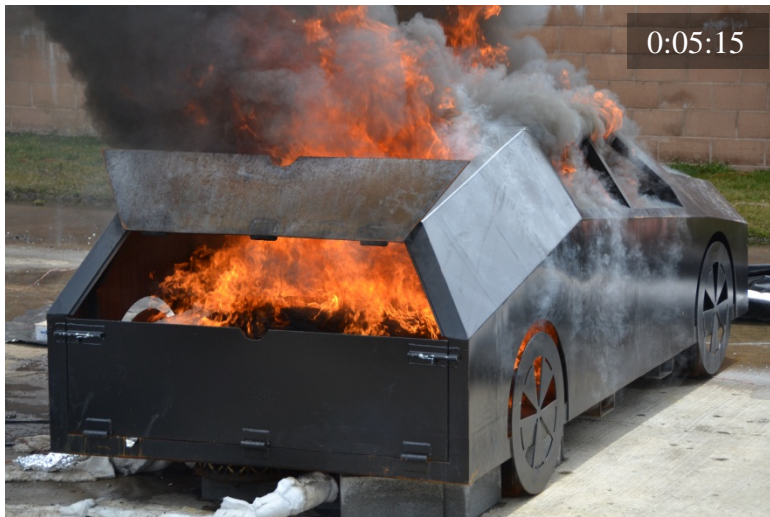
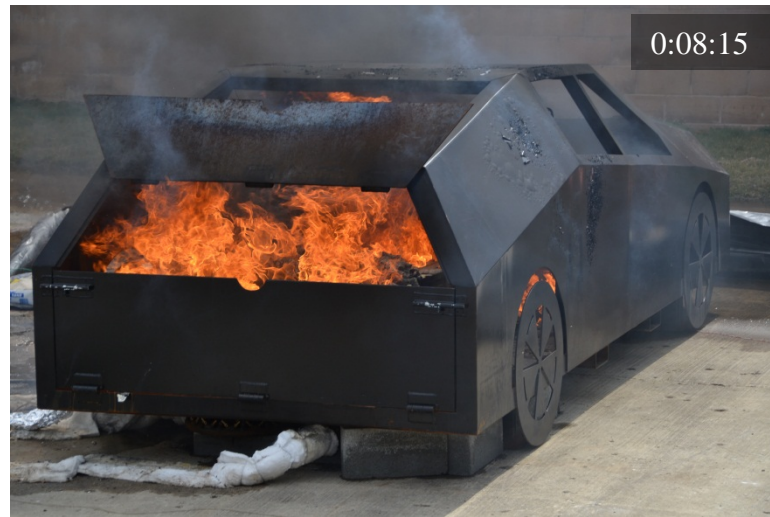
Figure 67 Test A3: ignition (top left); rear involved (top right); fully involved (bottom left); burners off (bottom right)

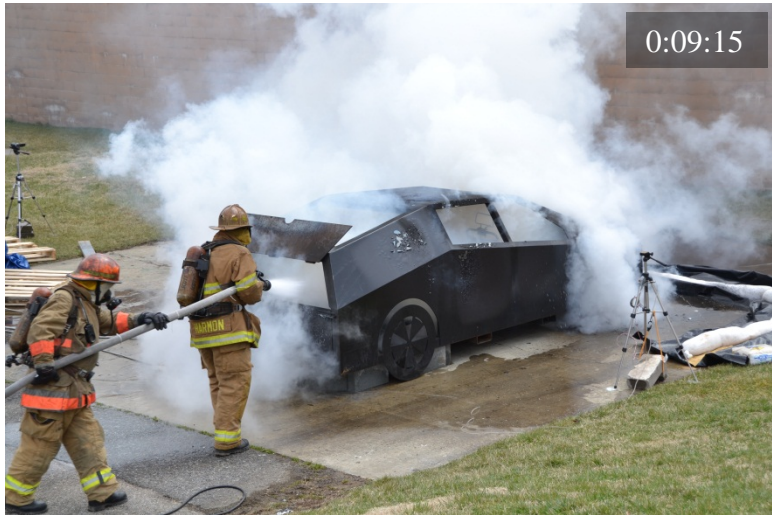
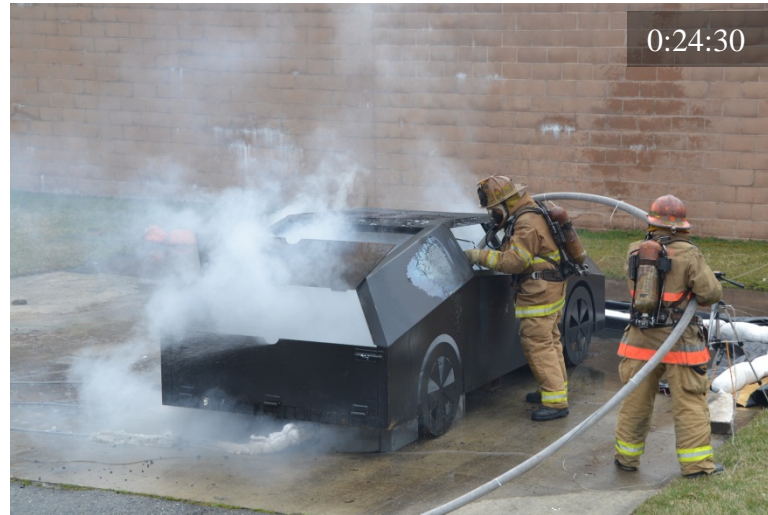
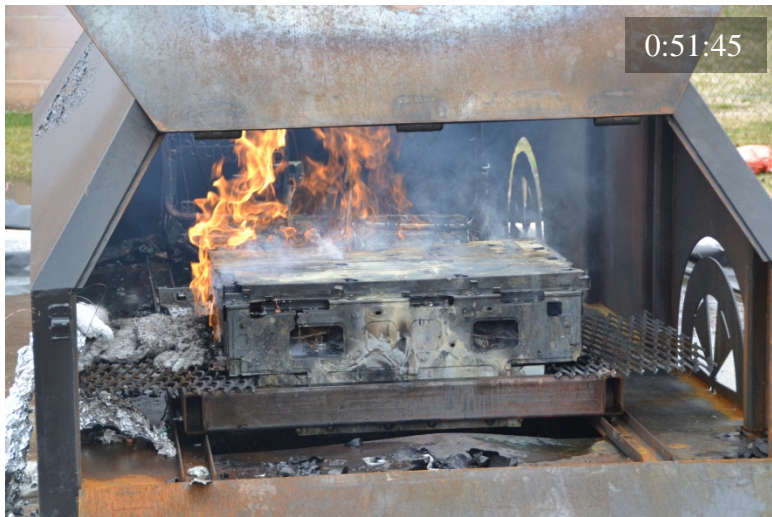
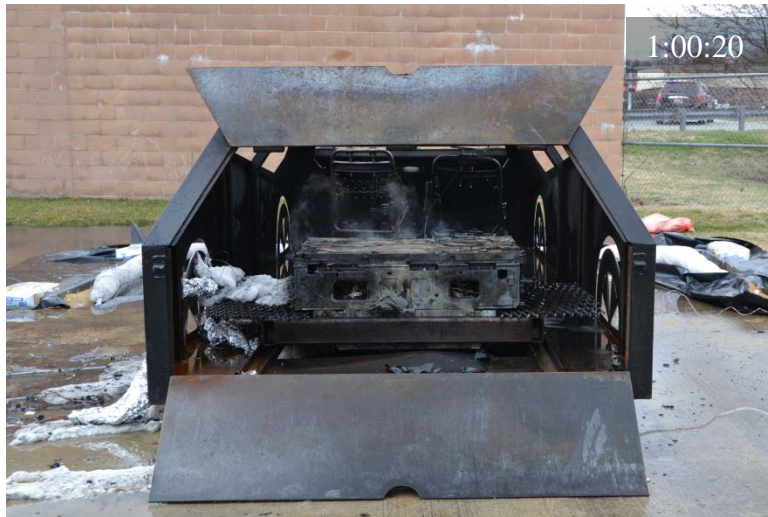
Figure 68 Test A3: Suppression starts (top left); reignition and suppression (top right, bottom left); post suppression (bottom right)

<b>Time</b>	<b>Event</b>
0:30:30	Smoke diminishing
0:30:48 – 0:39:05	Sporadic pops and white smoke off gassing
0:39:14	“Whoosh” heard, white smoke off gassing observed, battery fire reignited
0:42:51	Loud pop
0:44:30	Pops, white smoke off gassing, battery fire reignited
0:47:43	White smoke off gassing, battery fire reignited
0:50:27	Sporadic pops and white smoke off gassing
0:50:33	Battery fire reignited
0:51:21	Pops
0:51:28	Battery fire reignited
0:51:40	Pops, battery fire reignited
0:52:33	Arcing, battery fire reignited
0:53:07	Battery fire reignited
0:53:25	Battery fire reignited
0:54:32 – 0:55:37	Firefighters drizzle water over battery
0:57:04	Pops
1:00:00	DAQ system off

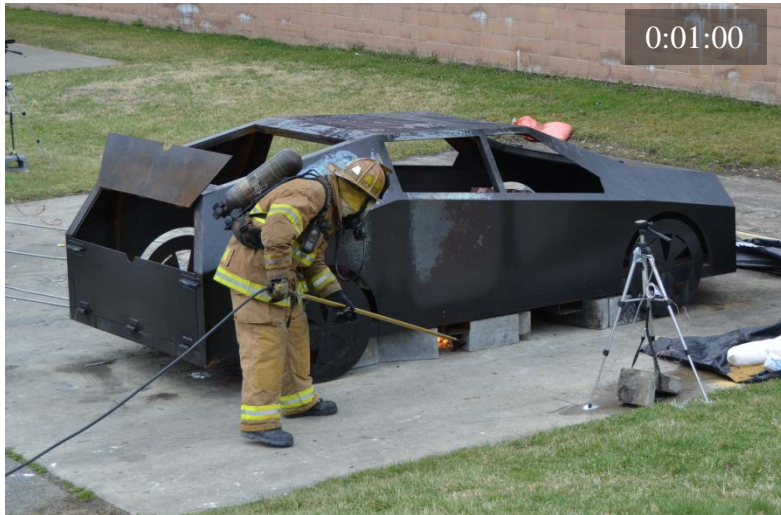
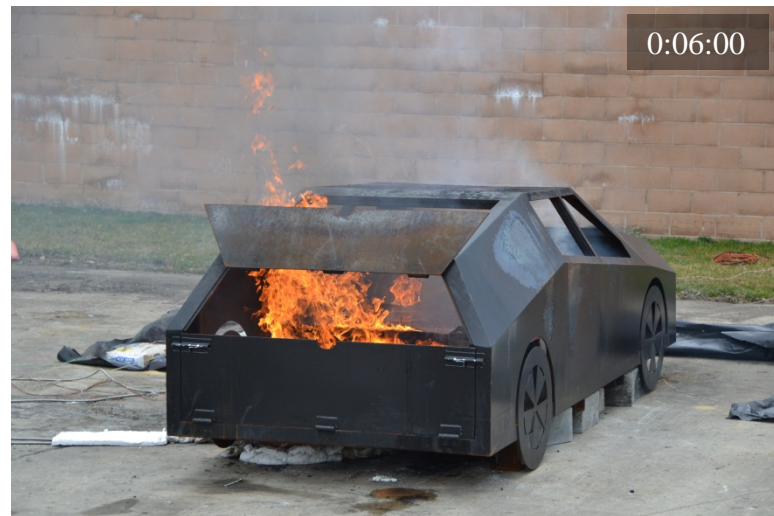
Figure 74 Test B1: ignition (top left); off gassing (top right); fully involved (bottom left); burners off (bottom right)
