# Best Practices for Emergency Response to Incidents Involving Electric Vehicles Battery Hazards: A Report on Full-Scale Testing Results

*Final Report*

Exponent, Inc.  
17000 Science Drive, Suite 200  
Bowie, MD 20715

© June 2013 Fire Protection Research Foundation

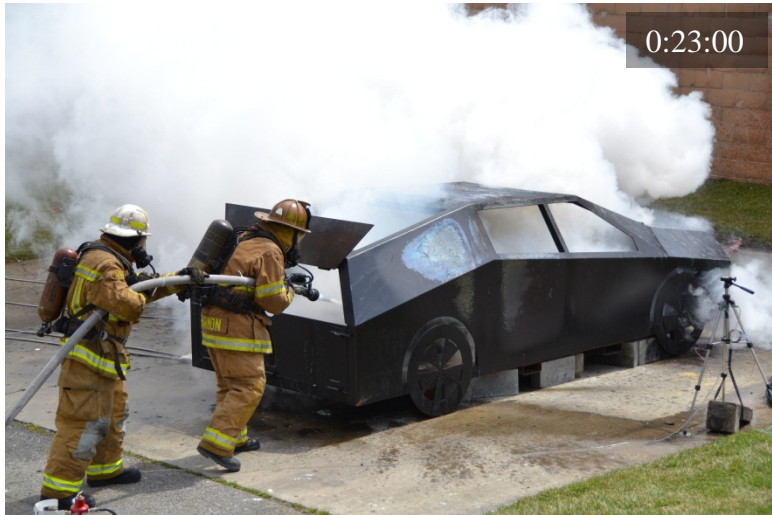
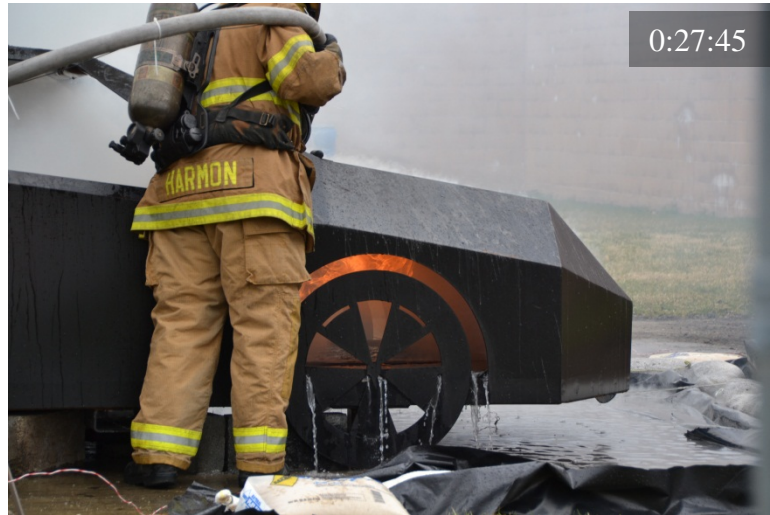
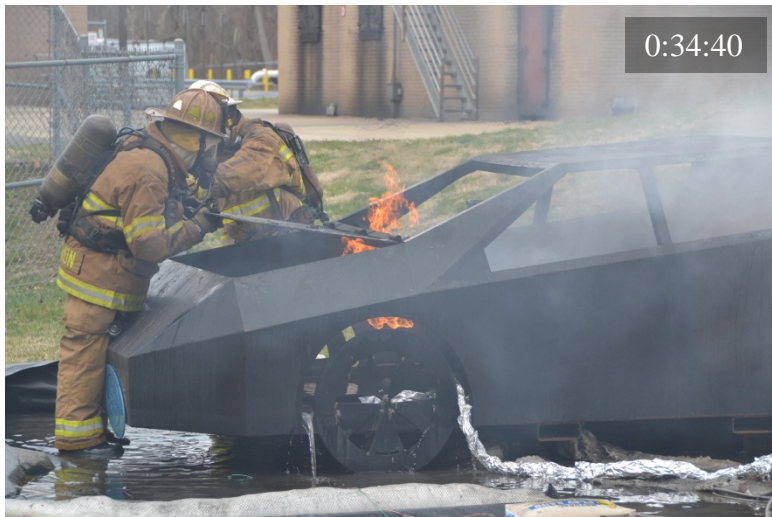
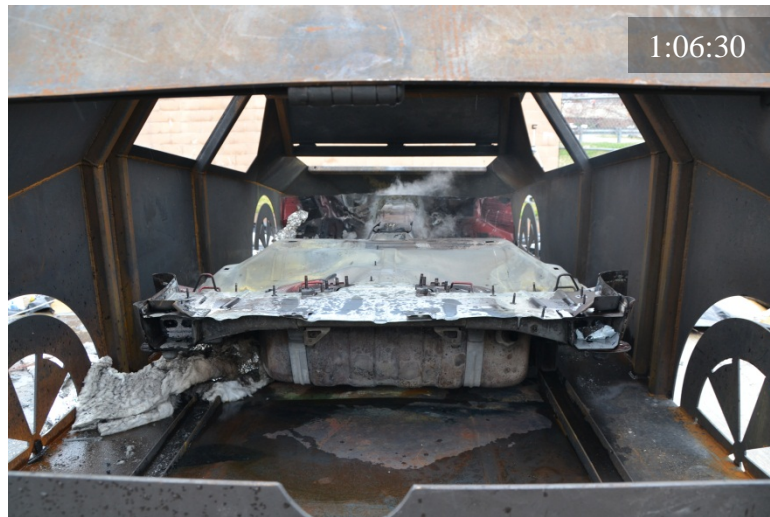
Figure 75 Test B1: suppression starts (top left); reignition and suppression (top right, bottom left); post suppression (bottom right)

0:38:25	Fire reignited at rear of battery, firefighters at front of battery
0:48:34	Active suppression ends
19:00:00	DAQ system off

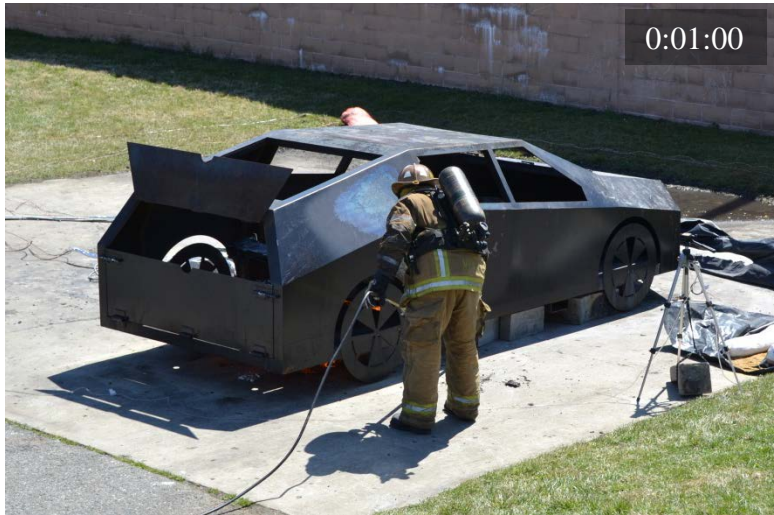
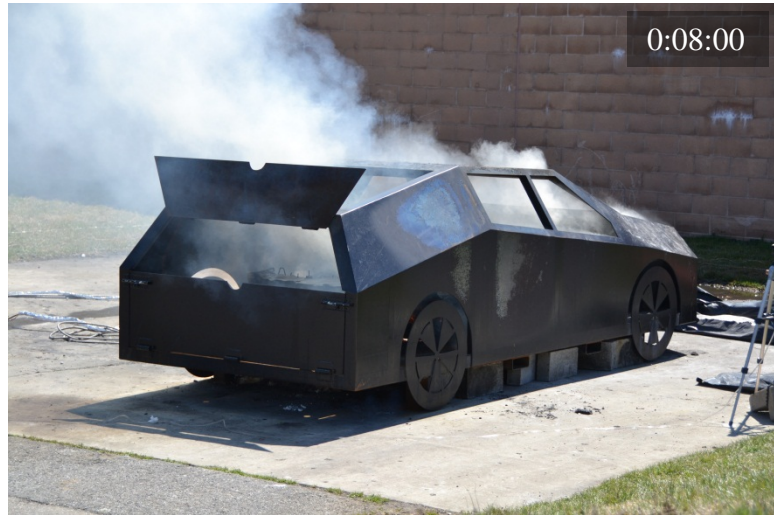
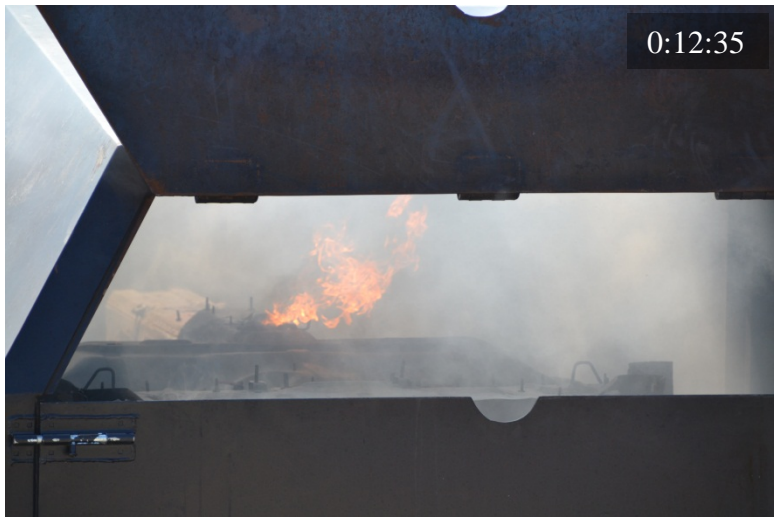
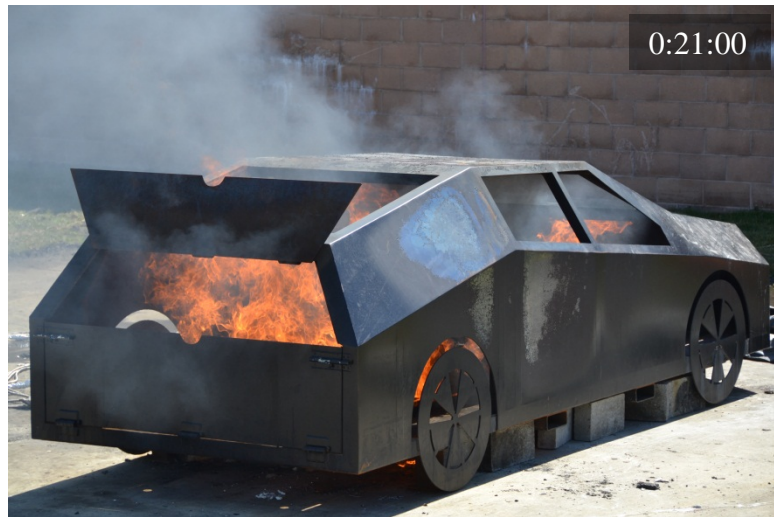
Figure 80 Test B2: ignition (top left); off gassing (top right); flames from fuse (bottom left); burners off (bottom right)

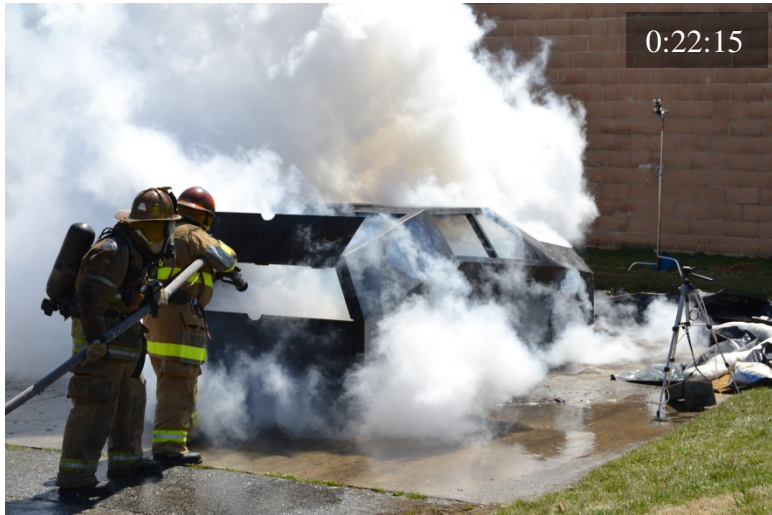
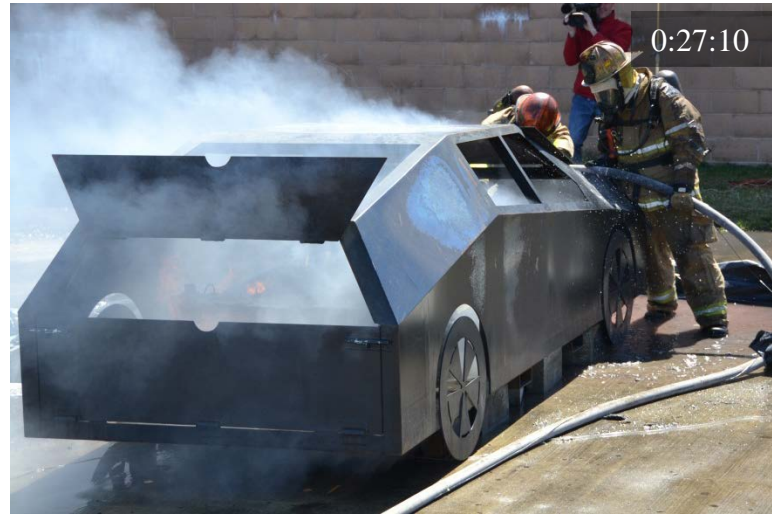
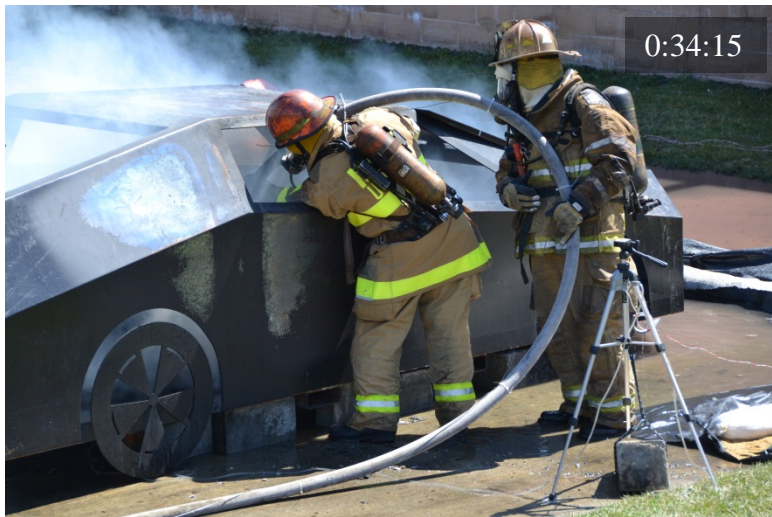
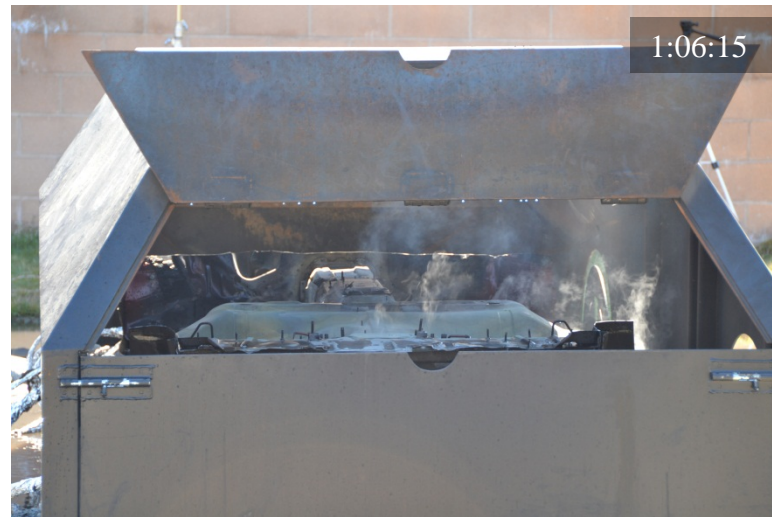
Figure 81 Test B2: suppression starts (top left); reignition and suppression (top right, bottom left); post suppression (bottom right)

<b>Time</b>	<b>Event</b>
0:38:10	Fire reignited below battery
0:38:13	Fire reignited
0:39:52	Firefighters swap out SCBA tank
0:40:41	Firefighters attack fire from rear of VFT
0:42:35	Firefighters attack fire from passenger side of VFT
0:43:35	Fire reignited below battery
0:46:33	Firefighters attack fire from front of VFT
0:55:06	Firefighters use hook to remove protective box from around the CAN bus connection area
0:56:40	Firefighters attack fire from passenger side of VFT
0:58:11	Active suppression ends
19:00:00	DAQ system off

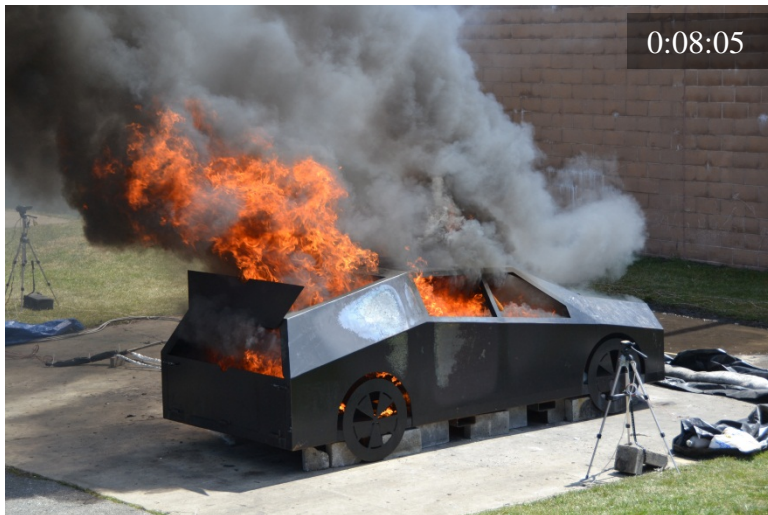
Figure 88 Test B3: ignition (top left); off gassing (top right); fully involved (bottom left); burners off (bottom right)

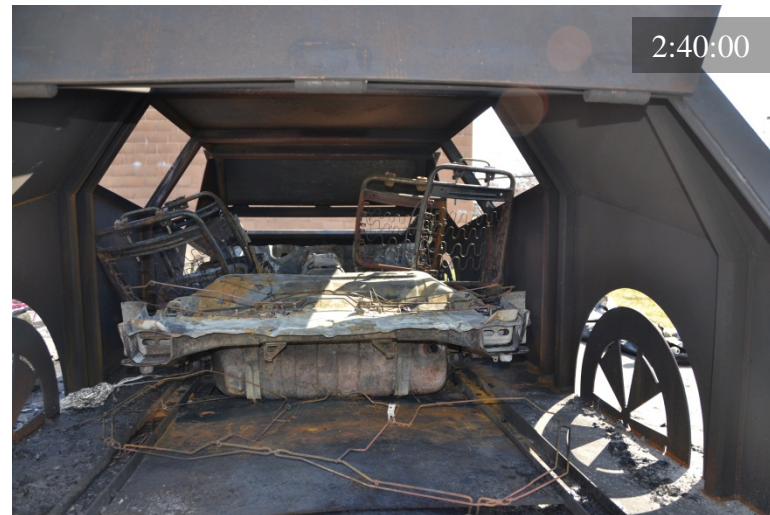
Figure 89 Test B3: suppression starts (top left); reignition and suppression (top right, bottom left); post suppression (bottom right)

<b>Time</b>	<b>Event</b>
0:29:36	Firefighters attack fire from passenger side of VFT
0:30:42	Firefighters attack fire from the front of VFT
0:33:04	Firefighters attack fire from the rear of VFT
0:34:28	Firefighters attack fire from rear wheel
0:35:24	Firefighters attack fire from passenger side of VFT
0:35:58	Active suppression ends
0:38:20	Firefighters swap out SCBA tank
19:00:00	DAQ system off
